Drivetrain - Front Driveshaft CV Joint Service

NO: 46-10

DATE: 4-27-2007

Propeller Shaft Front CV (constant velocity) Joint Available as a Spare Part

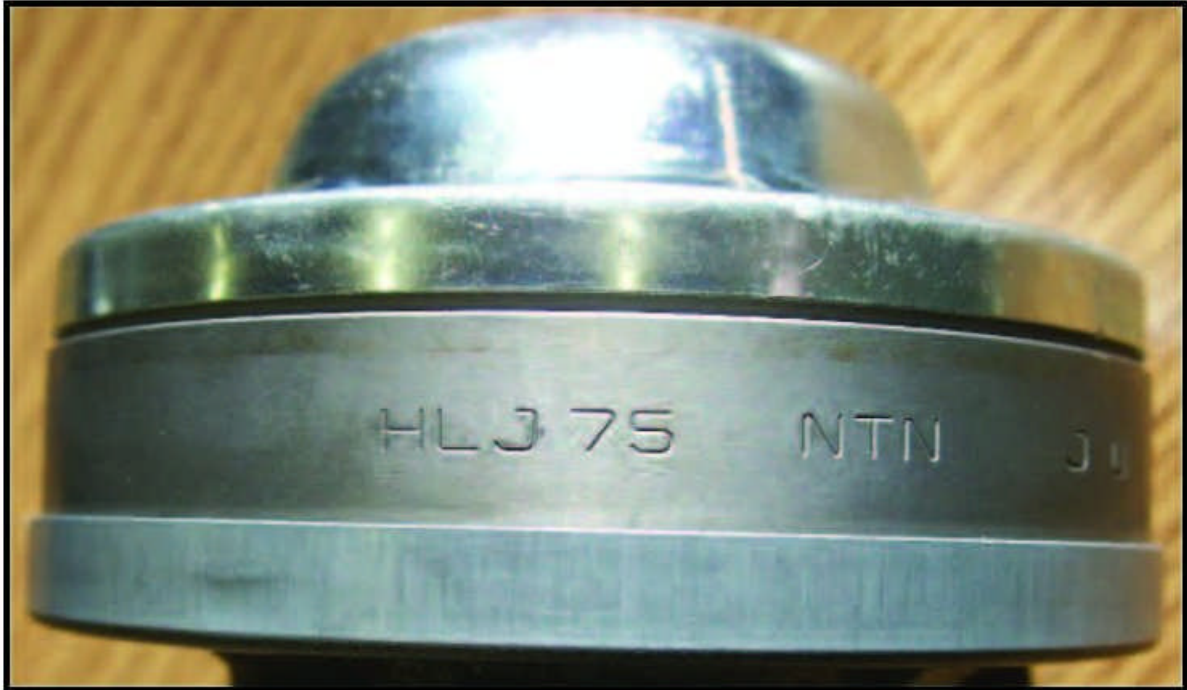
For reference purposes, the joints are physically marked as follows:

- PN 31216175, marked HLJ75
- PN 31216176, marked LJ75
- PN 31216177, marked BJ75L

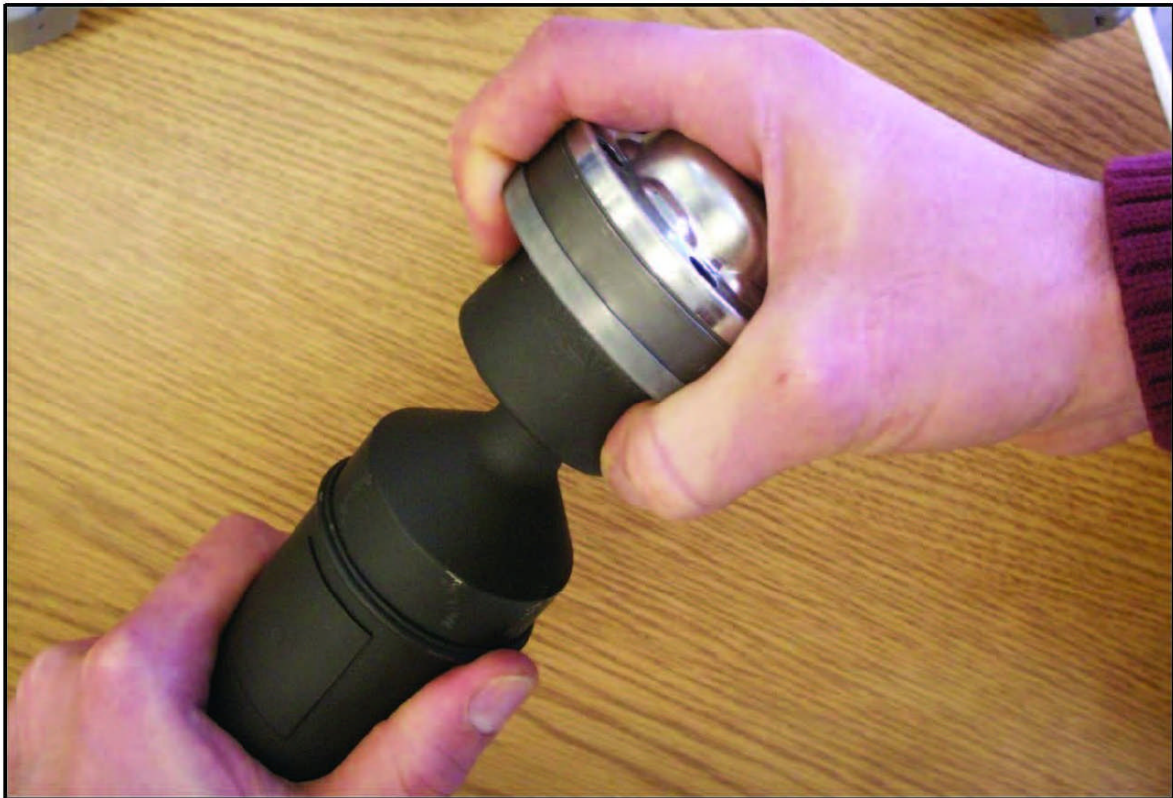
Note: When handling a propeller shaft out of the vehicle, it is important to support it so that the boot on the center joint is not damaged. Allowing the shaft to fold at the center joint may cause the boot to be cut by the edge of the joint.

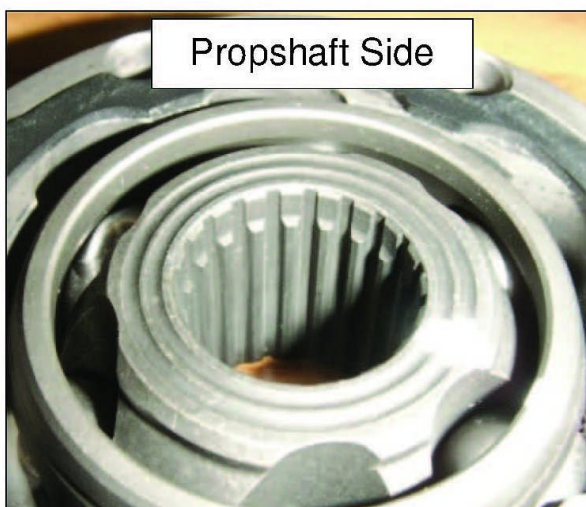
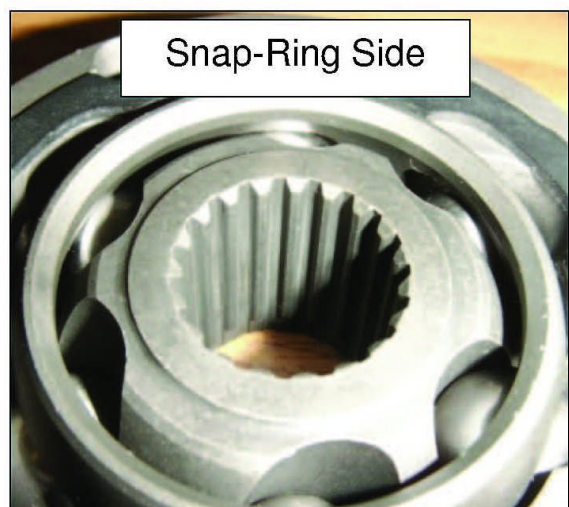
Note: It is normal for the front & rear joints to feel stiff when the propeller shaft is out of the vehicle. (These are not the same type of joints as the ones used on front axles.)

Note: The joint is not symmetrical. It should be installed according to the pictures.
