Body - Sunroof Water Leak

NO: 83-34

MODEL: XC90 (03-)

SUBJECT: Water Leak from Sunroof, Fault Tracing and Service.

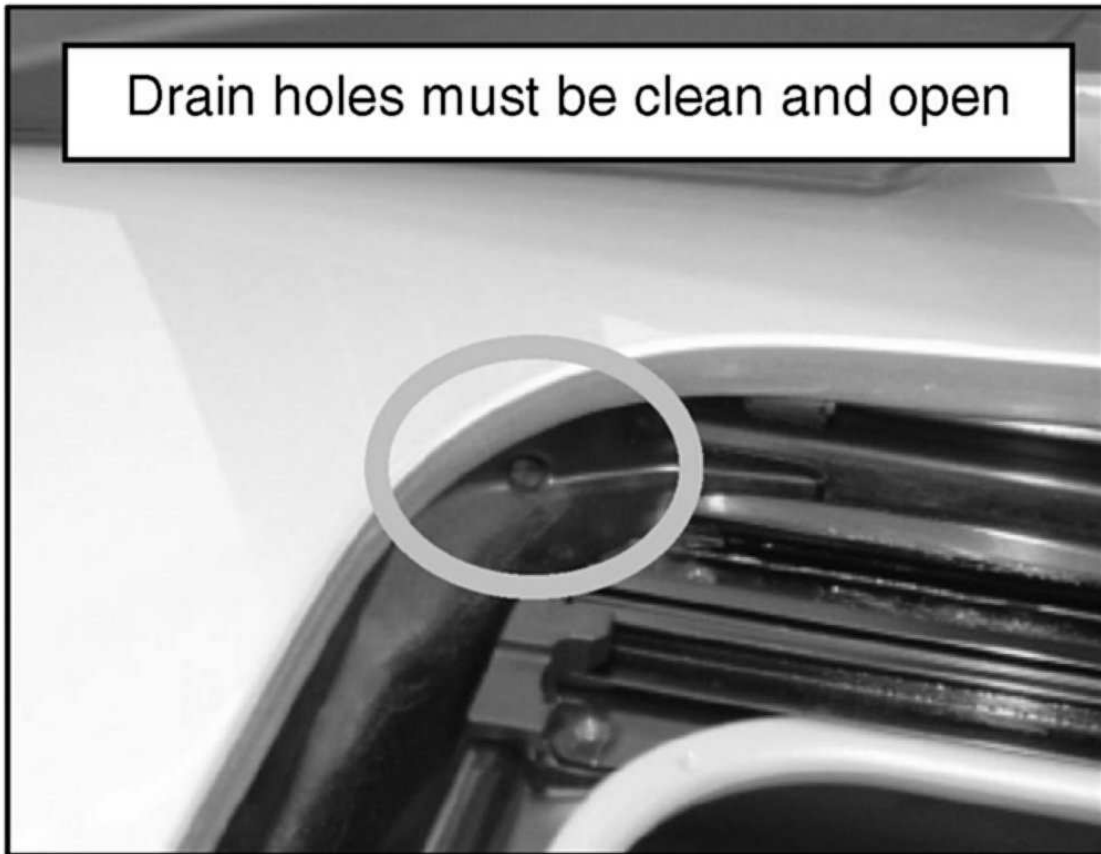
Step 1.1 Check front drainage holes (both sides):

Open the sunroof and check the drainage holes at the left and right front corner from the sunroof cassette. Both holes should be free of leaves and dirt.

Service: remove any dirt or debris.

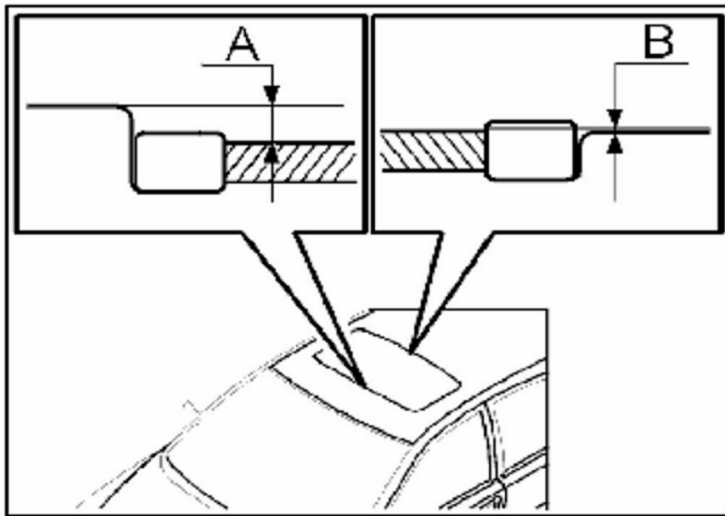
Checking the vertical position at front end rear edge of the glass panel:

Front edge: The top of the glass must be flush or maximum 0.04 inch (1 mm) under the roof panel. (See dimension A).

Rear edge: The top of the glass must be flush or maximum 0.04 inch (1 mm) above the roof panel. (See dimension B).

If the sunroof fitting is not according to specification, follow instructions as per VADIS for adjustment. (Function Group 8, Repair and installation instructions, Sunroof, adjusting).

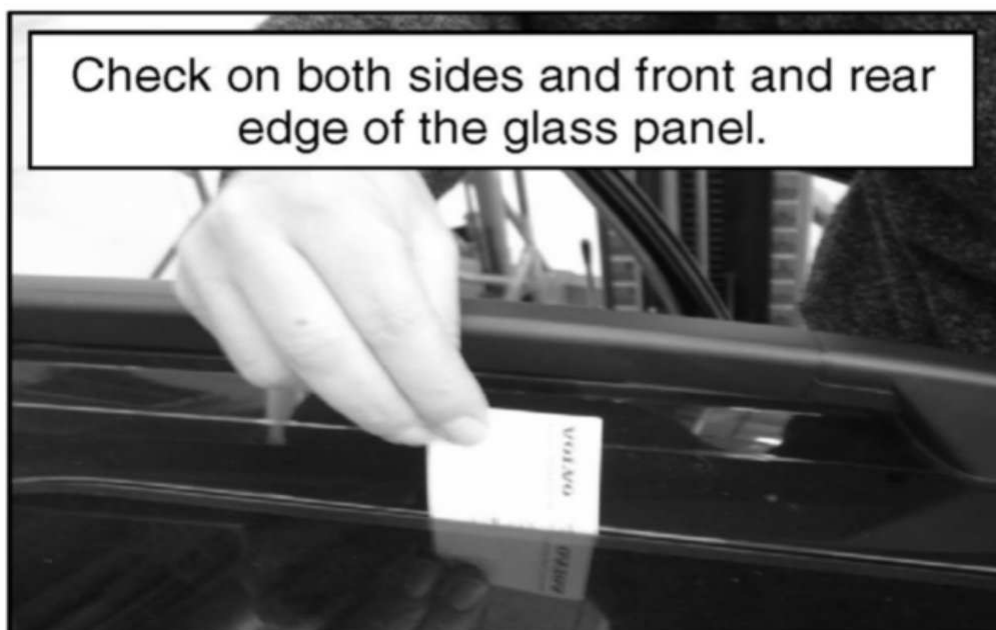
Checking the horizontal position of the glass panel:

The sunroof must be centered in the opening.
Verify that there is even pressure on the seal on both sides and along front and rear edges of the glass panel.

This can be done visually and with a piece of paper (e.g. business card).
Insert card and pull out to feel the pressure between the seal and the roof plate.

Compare all four sides to determine if the sunroof is not centered.

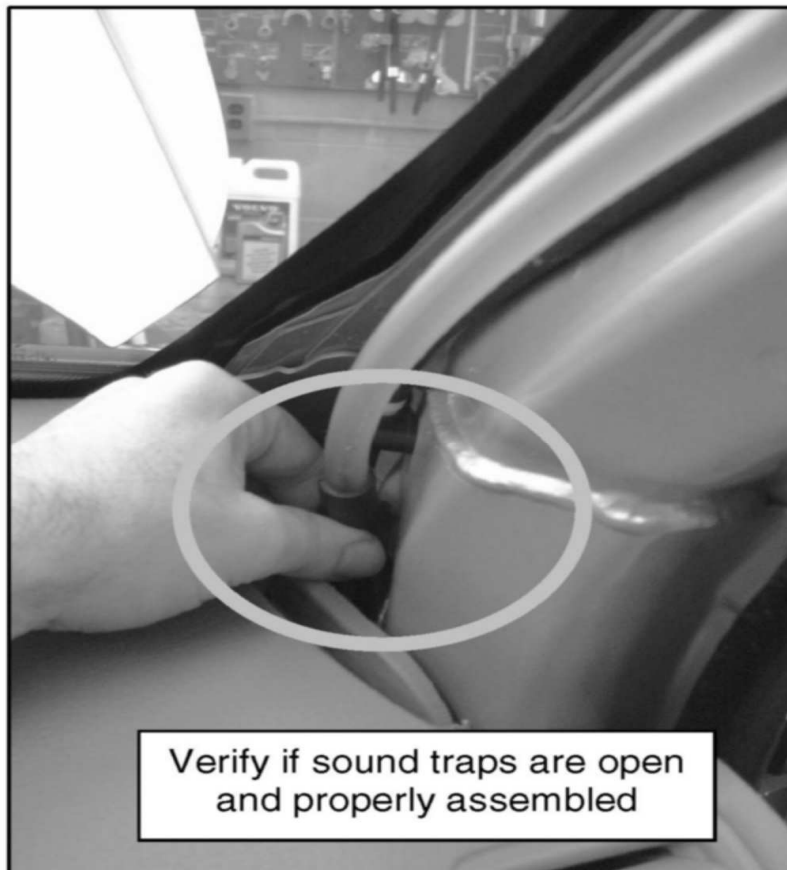
Step 1.3 Check front sound traps in the A-pillar (both sides):

Disassemble A-pillar panels according VADIS.
Pull the rubber sound traps out of the holes in the front A-pillars and verify that they are open and clear from debris or dirt.

Verify connection of drainage hose and sound trap.
Make sure the hose is fully inserted.
Verify proper assembly of the rubber grommet on the
sound trap into the hole in the A-pillar.

Clean the sound traps. Enlarge the opening of the front sound traps on cars with chassis number between 000690-171367.

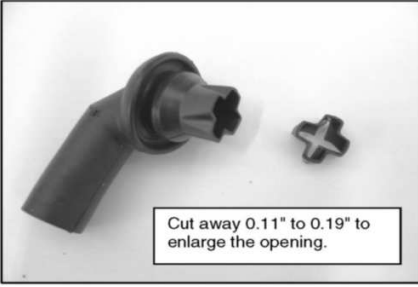
Modification for cars with chassis number between 000690-171367	
<p>A modification for the sound traps in the A-pillar is recommended.</p> <p>Use a scissors to cut 0.11" to 0.19" from the sound trap as shown in the picture.</p> <p>This will enlarge the opening and prevents the sound trap from clogging.</p> <p><i>Cars after the chassis number limits are modified from the factory.</i></p>

<p>Cut away 0.11" to 0.19" to enlarge the opening.</p>

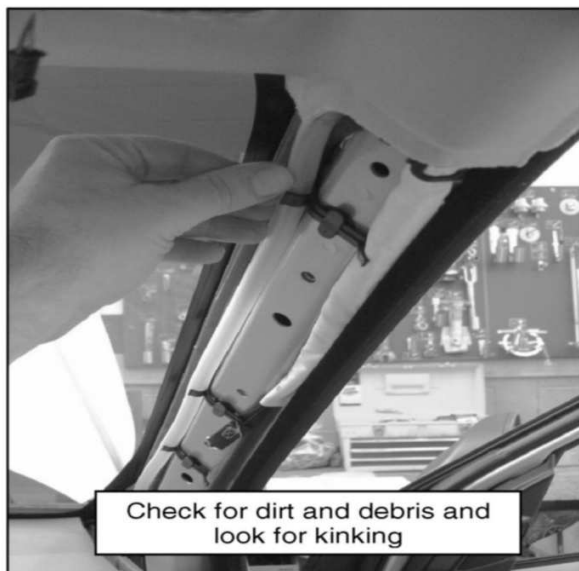
Step 1.4 Check front drainage pipes along A-pillar (both sides):

Check routing of the hose along the A-pillar and verify that the hose is free of dirt and debris.

If the hose is clogged, clean or replace the hose.

If the hose is kinked, replace the hose.

A similar type of hose with better rigidity than the original hose can be used to avoid kinking.

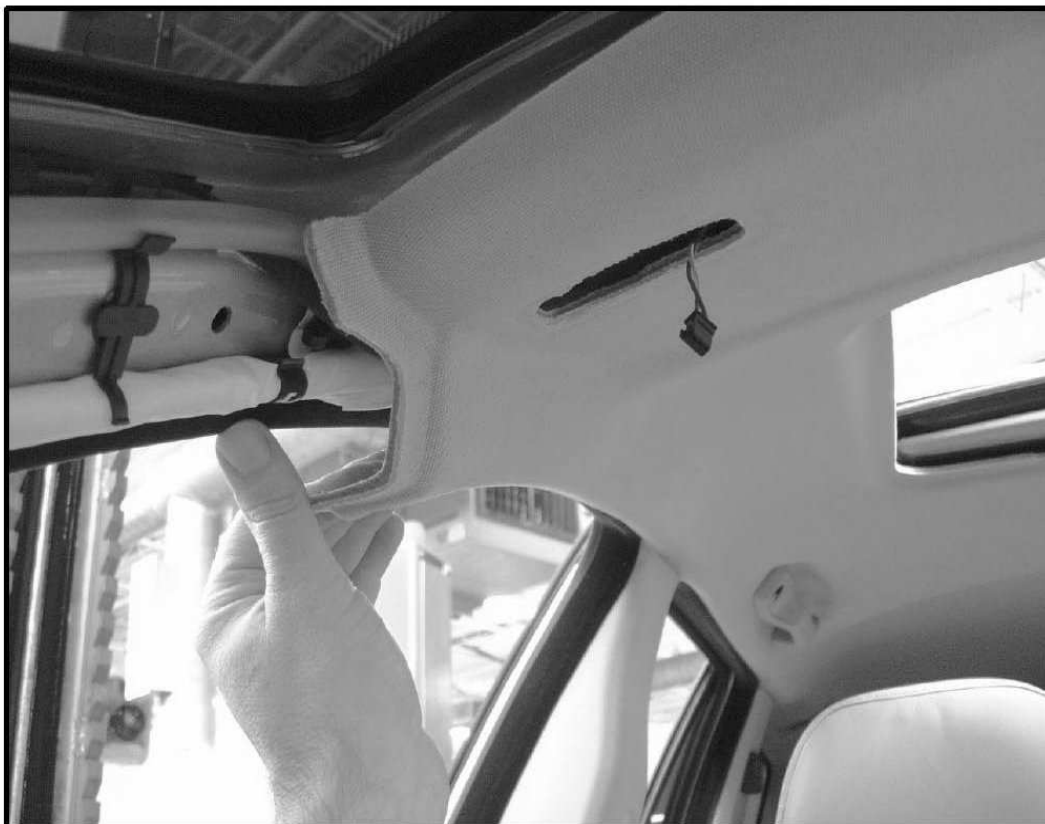
Step 1.5 Check upper part of front drainage (both sides):

Disassemble the [sun visors](#) and the front interior light panel according to VADIS.

Release the headliner from the rubber seals in the door opening and the B-pillar panel.

Pull the headliner down to allow inspection of the drainage hoses behind the headliner.

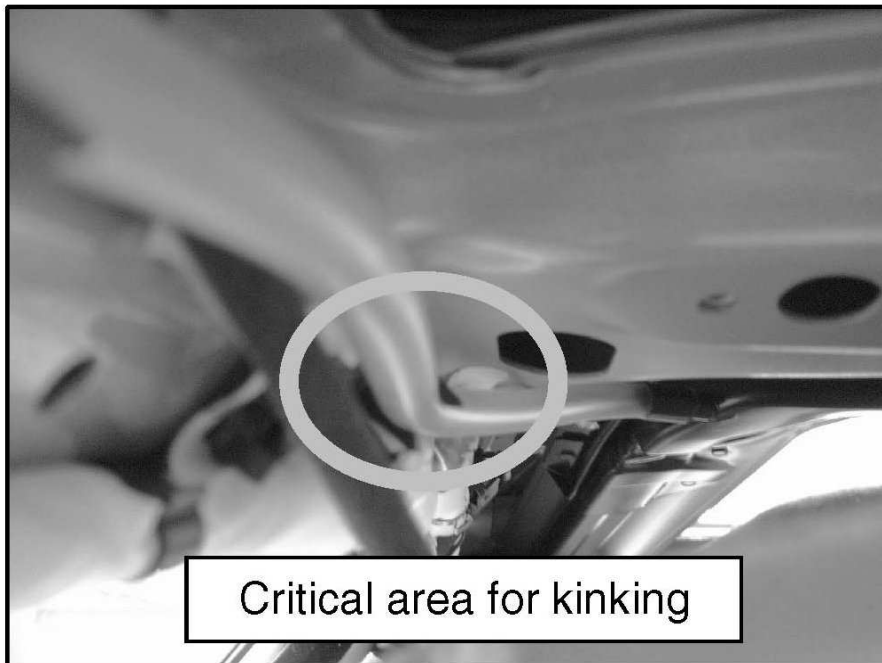
Verify routing and look for possible kinking.
Verify that the hose is clear of dirt and debris.

Service: Replace the hose if kinked or clogged.

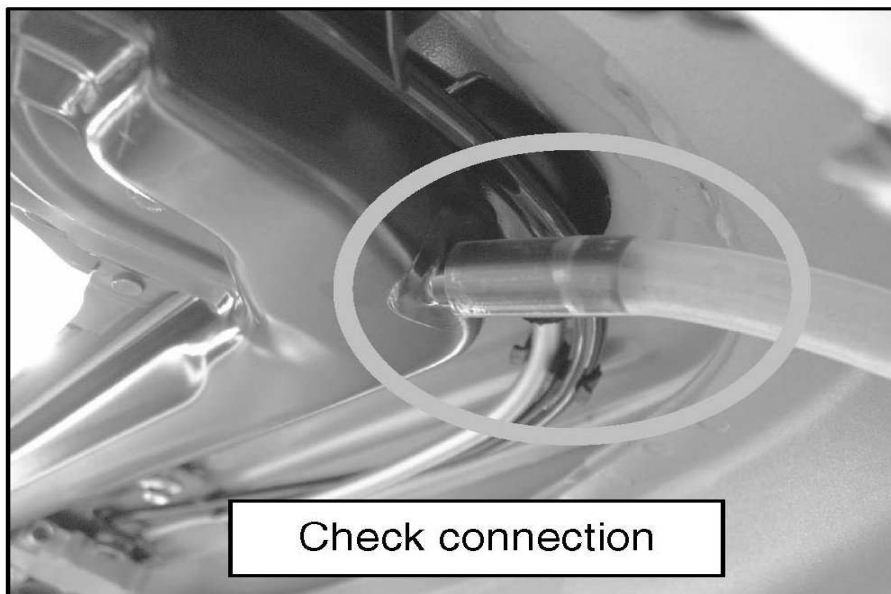
Verify connection between the hoses and the gutter pipes at the front left and right side of the sunroof cassette.

Make sure the hose is pushed all the way onto the gutter pipe.

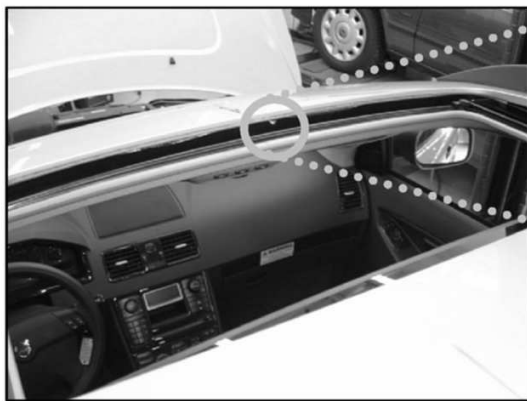
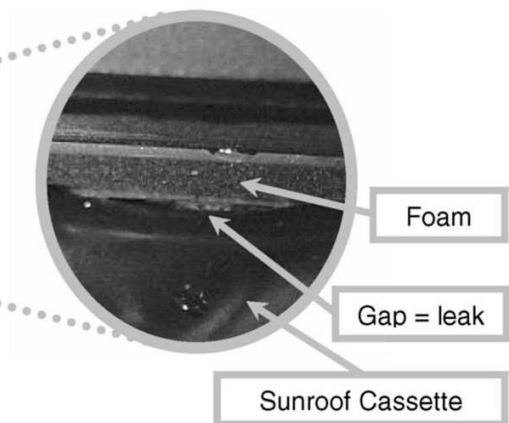
Step 2.1 Check foam between cassette and roof, front center:

Under certain conditions, a small gap might occur at the foam between the sunroof cassette and the roof plate. The critical area is in the front center where a hole is punched in the sunroof cassette. Check the position of the foam; it should be covering the complete hole.

Service: Use PUR sealant or similar to close the gap.
