Driveline/Exhaust - High Pitched Squealing Noise

NO: 25-21

AWD S60 /S80 / V70 / V70 XC / XC70 / XC90

High Pitched Squealing Noise, Exhaust Touching Propeller Shaft.

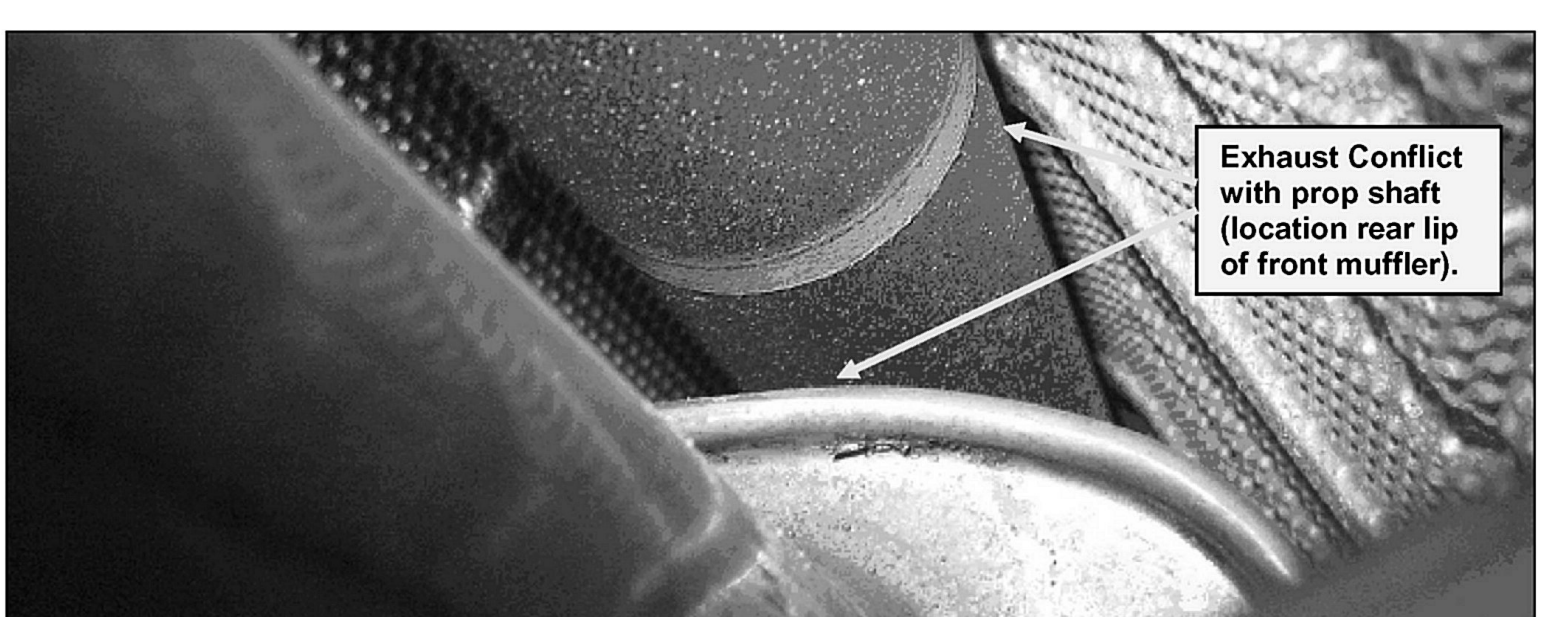
Under certain conditions when driving through puddles of water, slush and or snow, the underside of exhaust system may cool down fast enough causing the exhaust to change shape and touch the propeller shaft, causing a very high pitched squealing noise. This noise will be noticed by the driver for only a short time, once the exhaust temperature equalizes the noise will disappear. If the customer should have this complaint a tell tale mark will be left on the propeller shaft (see illustration shown).

Should the customer experience this condition please install the exhaust support kit, following the instructions listed below.
