Engine - Lubrication System Contamination Cleaning

NO: 20-05

Procedure for Cleaning Engine Oil System Contamination.

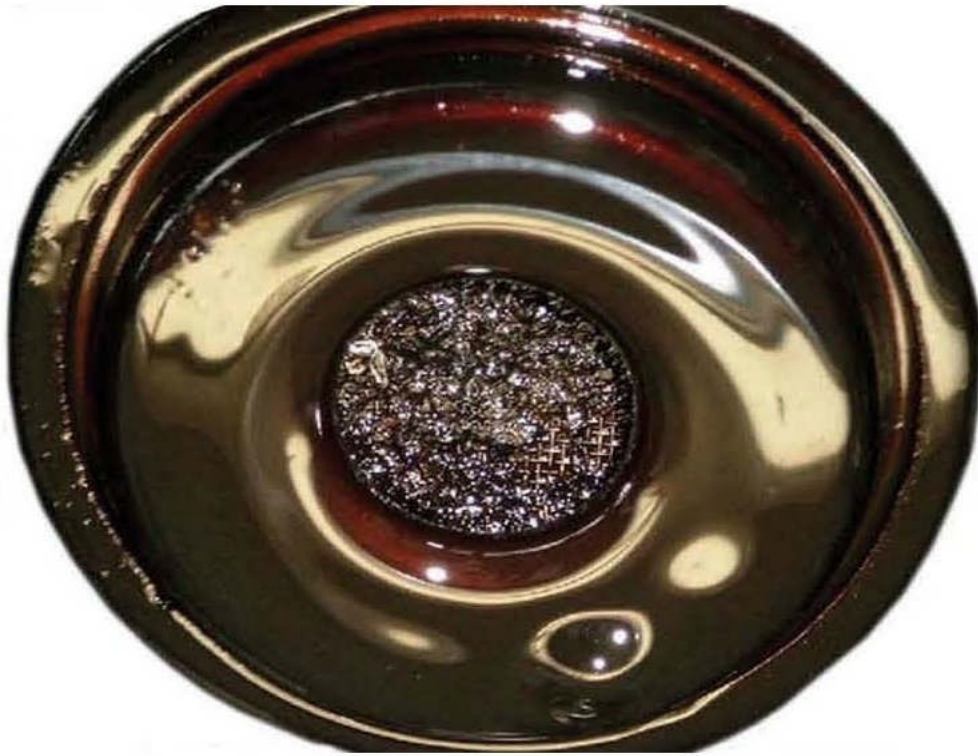
- Illuminated oil pressure lamp. Due to clogged oil suction strainer to [oil pump](#) and/or [oil filter](#) (see illustration)

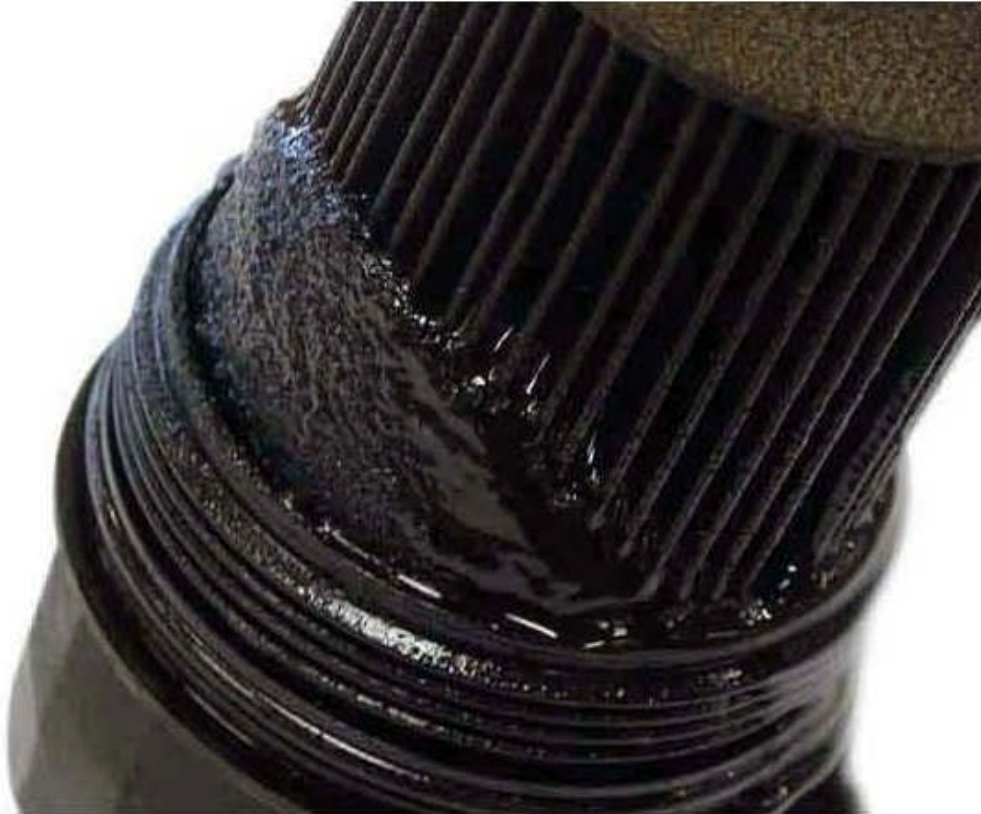
IMG-245347

The first step is to inspect the [oil filter](#) to see if it is abnormally dirty. An abnormally dirty filter is easily recognized by its thick, black deposits. Engines with spin-on [oil filters](#) can be inspected by sawing the filter in half.

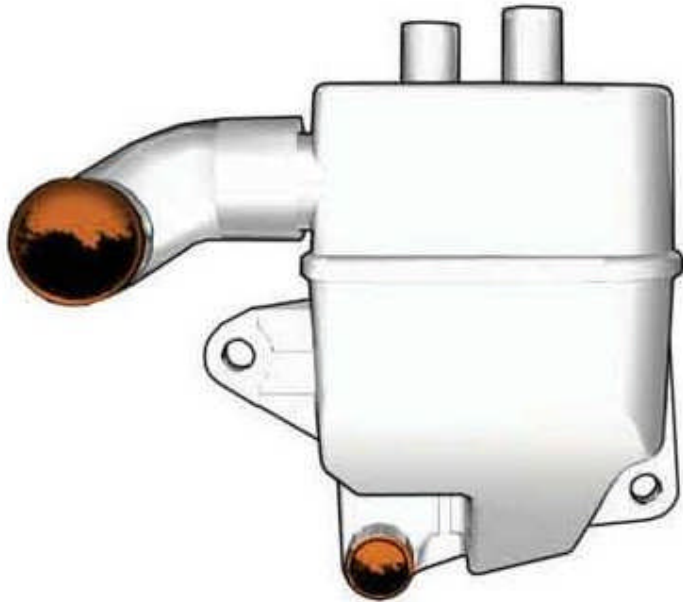
IMG-245348

If the engine has a problem with carbon deposits, the passageways in the engine block and oil trap may be completely or partially clogged. See illustration. Remove and check the oil trap, hoses and their passageways in the engine block. There should not be any major collections of carbon deposits in the hoses or in the passageways in the block.

Clean the engine block passageway from the oil trap and the oil trap passageway in the block. Use a screwdriver or similar small scraping tool and blow the passageways clean with

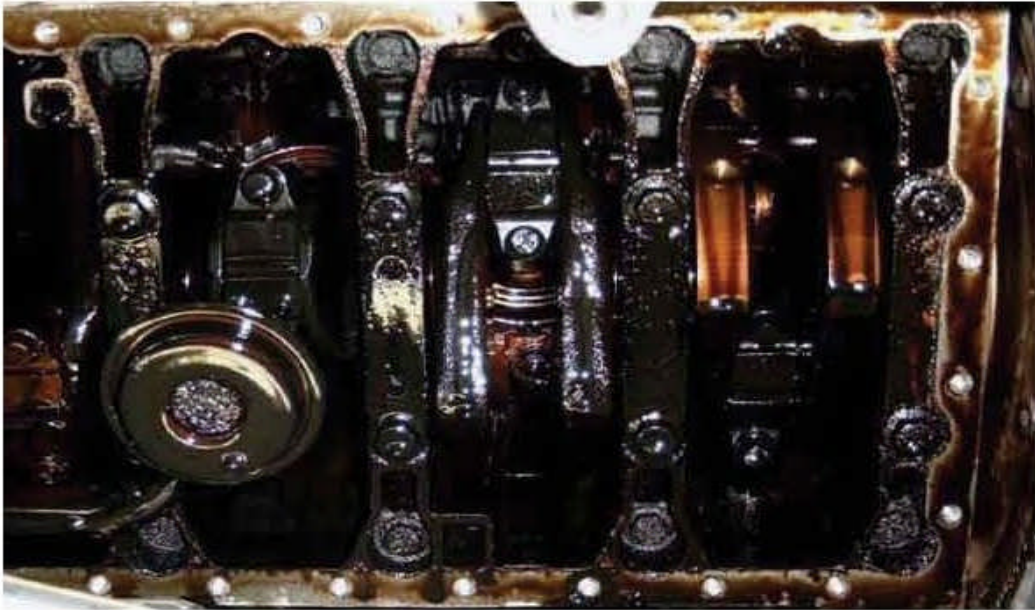
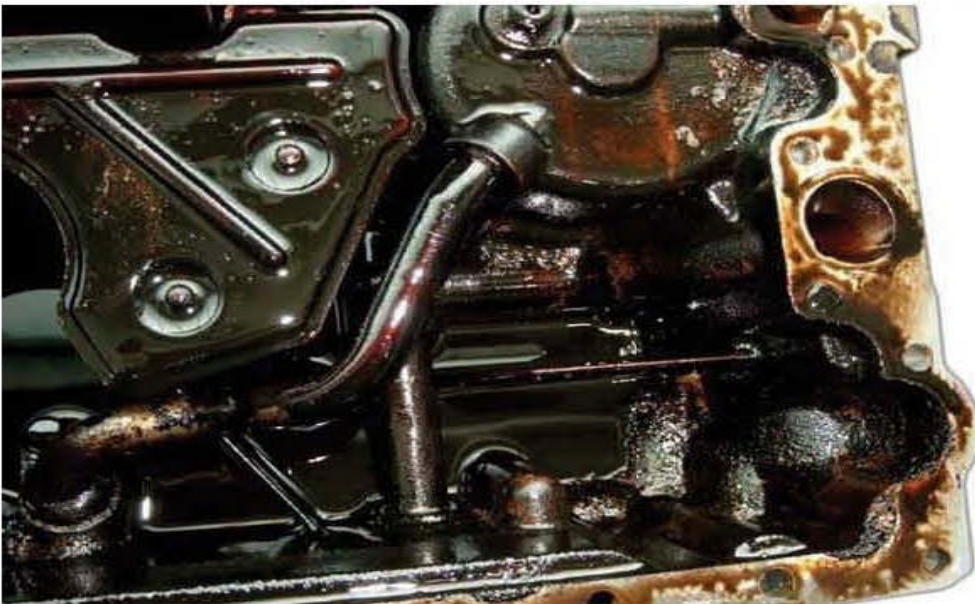
Remove the oil sump and check the oil sump and crankcase for deposits.

Normally, there should not be any deposits. A slight light brown discoloration is however normal.

The figures show an engine with heavy deposits.

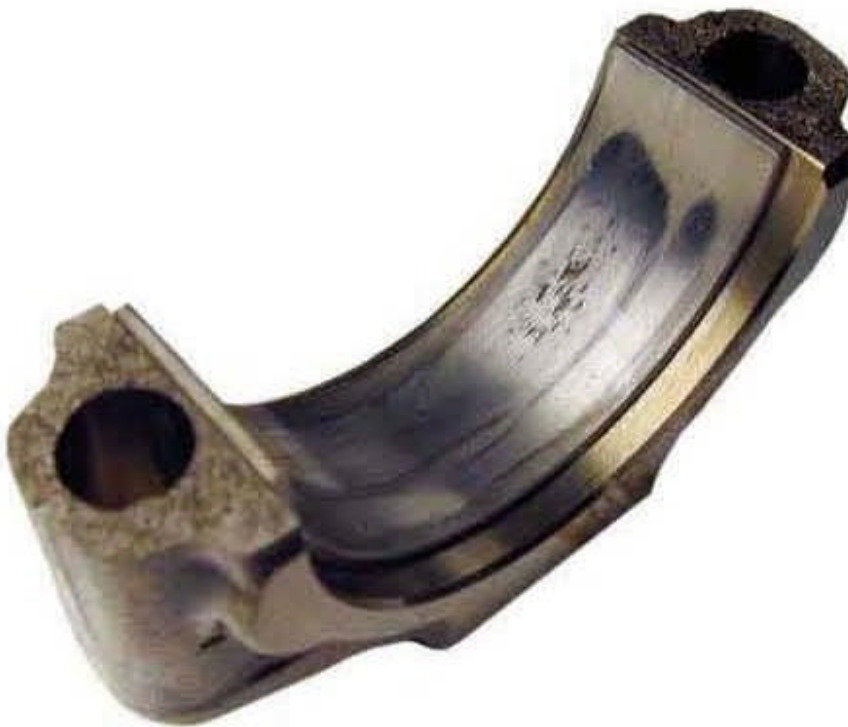
Checking big-end bearings

See information in VIDA for engine variant in question.

If big-end bearing no.2 is damaged, replace all big-end bearings.

Note! If any bearing is damaged, check the [crankshaft](#) for scratches.

If the [crankshaft](#) is damaged, discontinue troubleshooting and replace the engine.

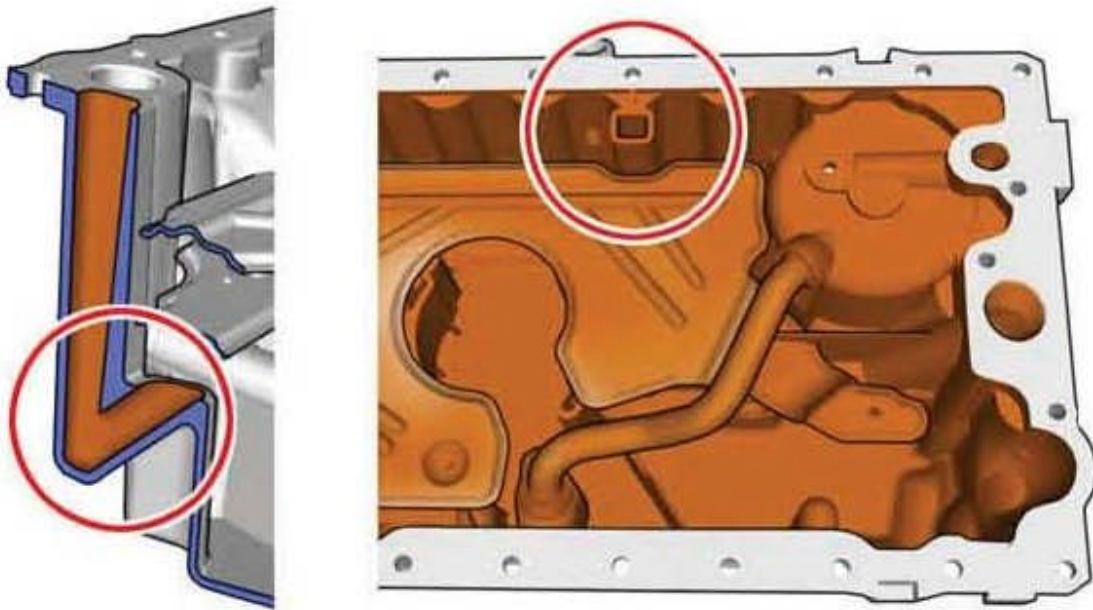
Note! Make sure that the oil sump passageway from the oil trap is fully cleaned. See illustration. Blow clear with compressed air to ensure the duct is thoroughly cleaned.

Clean the inside of the oil sump by removing any loose deposits.

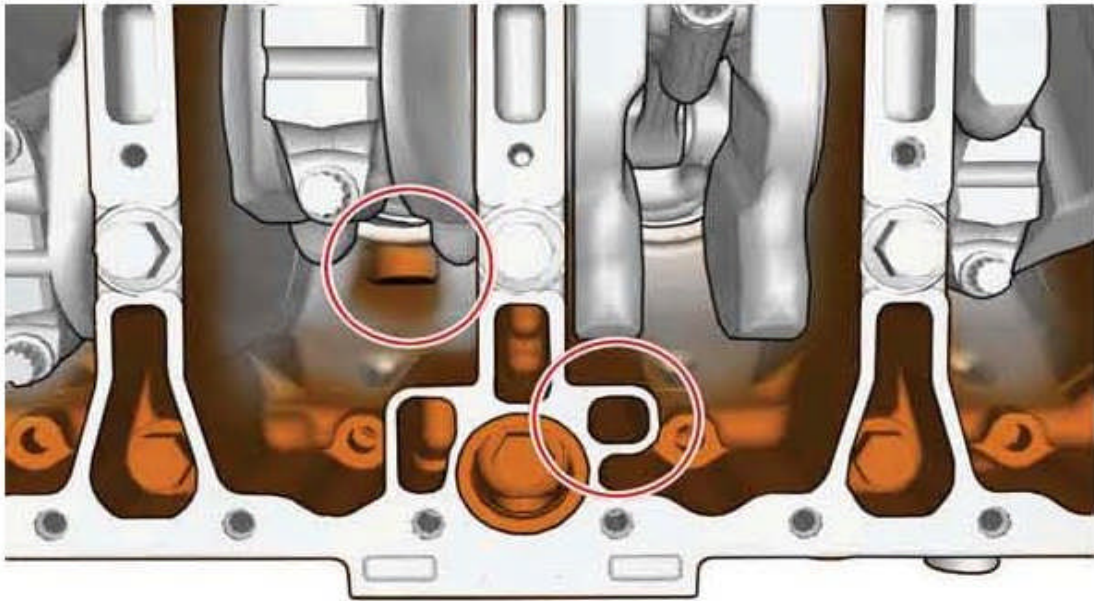
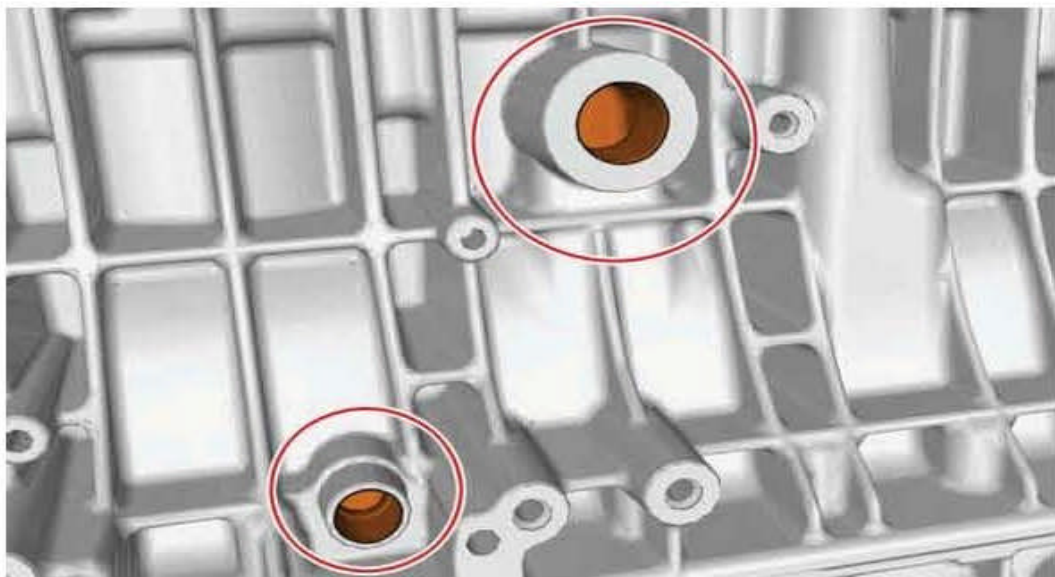
Perform a general cleaning of the crankcase to remove all the carbon deposits. All loose deposits must be thoroughly cleaned.

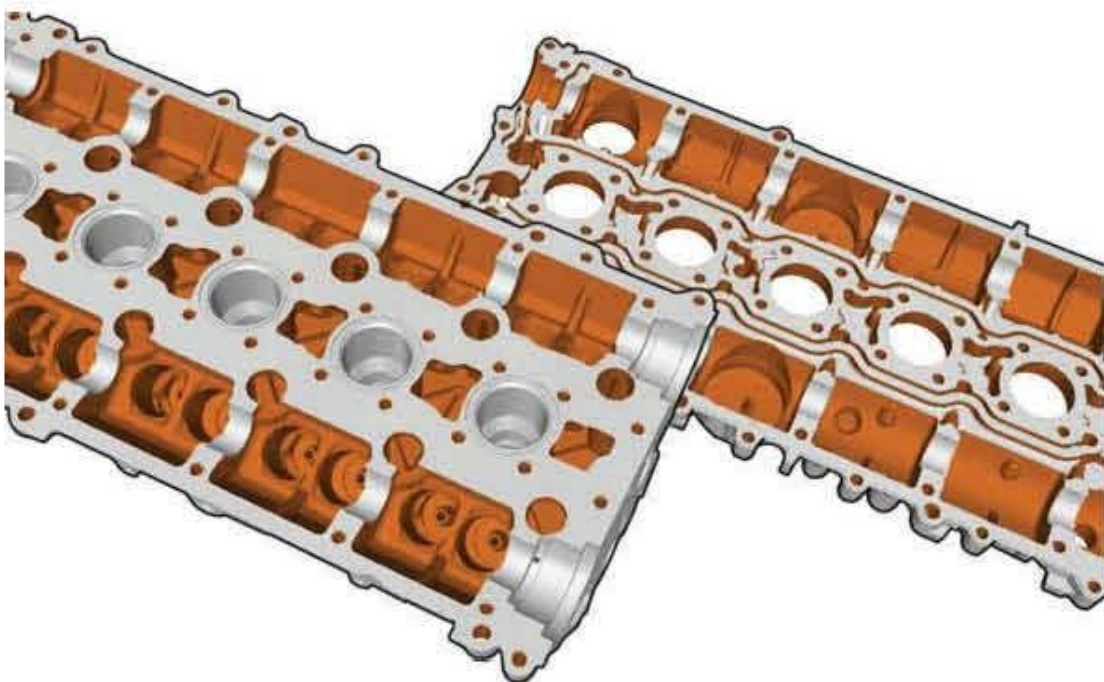
Remove carbon deposits with a suitable tool, knife, scraper or the like. Then wash the cylinder head and cam carrier cover in a parts cleaning machine as described in step 8.

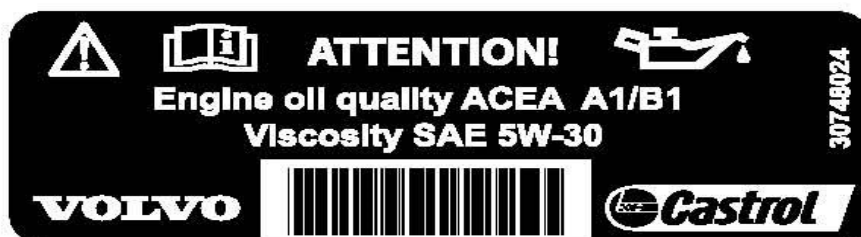
Affix the oil decal (part no.30748024) on the upper [radiator](#) member. Remove any existing decal.
