A/T - Cooler/Line Flushing When Replacing A/T

NO: 43-56

Automatic Transmission Cooler/Lines Flushing

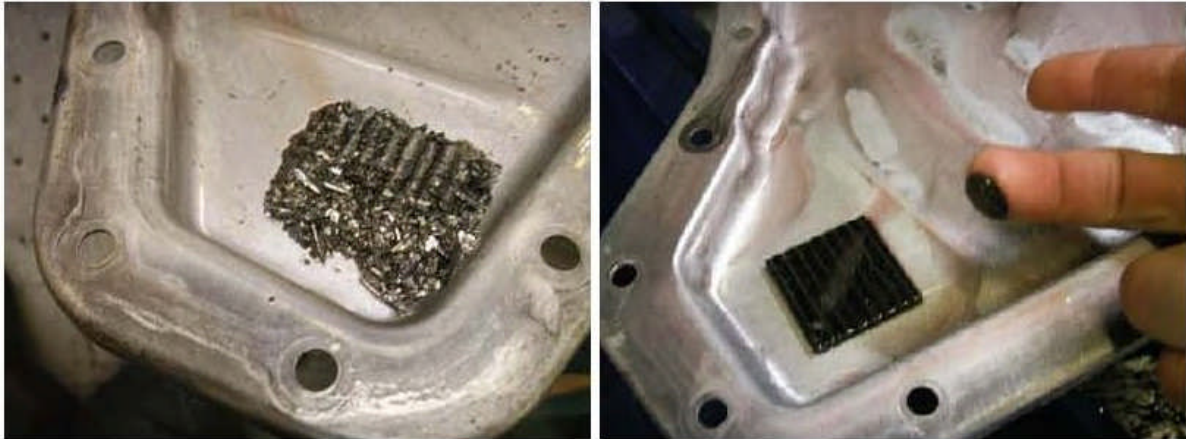
Note! Metal in the [ATF](#) is nearly impossible to flush out completely. In order to be rid of all metal particles, complete replacement of the ATF cooling system (radiator, auxiliary cooler [if applicable], and cooler lines) is required. See photo. Black sediment on the pan magnet is normal. See photo.

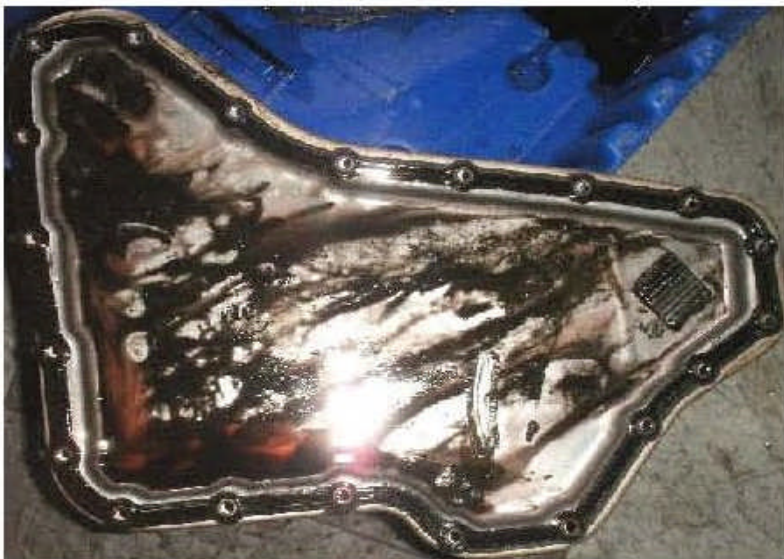
^ dirty oil or oil that has surpassed its temperature limits, this would indicate friction component (band or clutch disc) breakdown and in order to be sure all of the debris is out of the [ATF](#) cooling system, complete replacement of the ATF cooling system (radiator, auxiliary cooler [if applicable], and cooler lines) is required. See photo.
