Geartronic shift knob button replacement. IPDUSA sells just the button and they include instructions but I thought a few more pictures would help out.

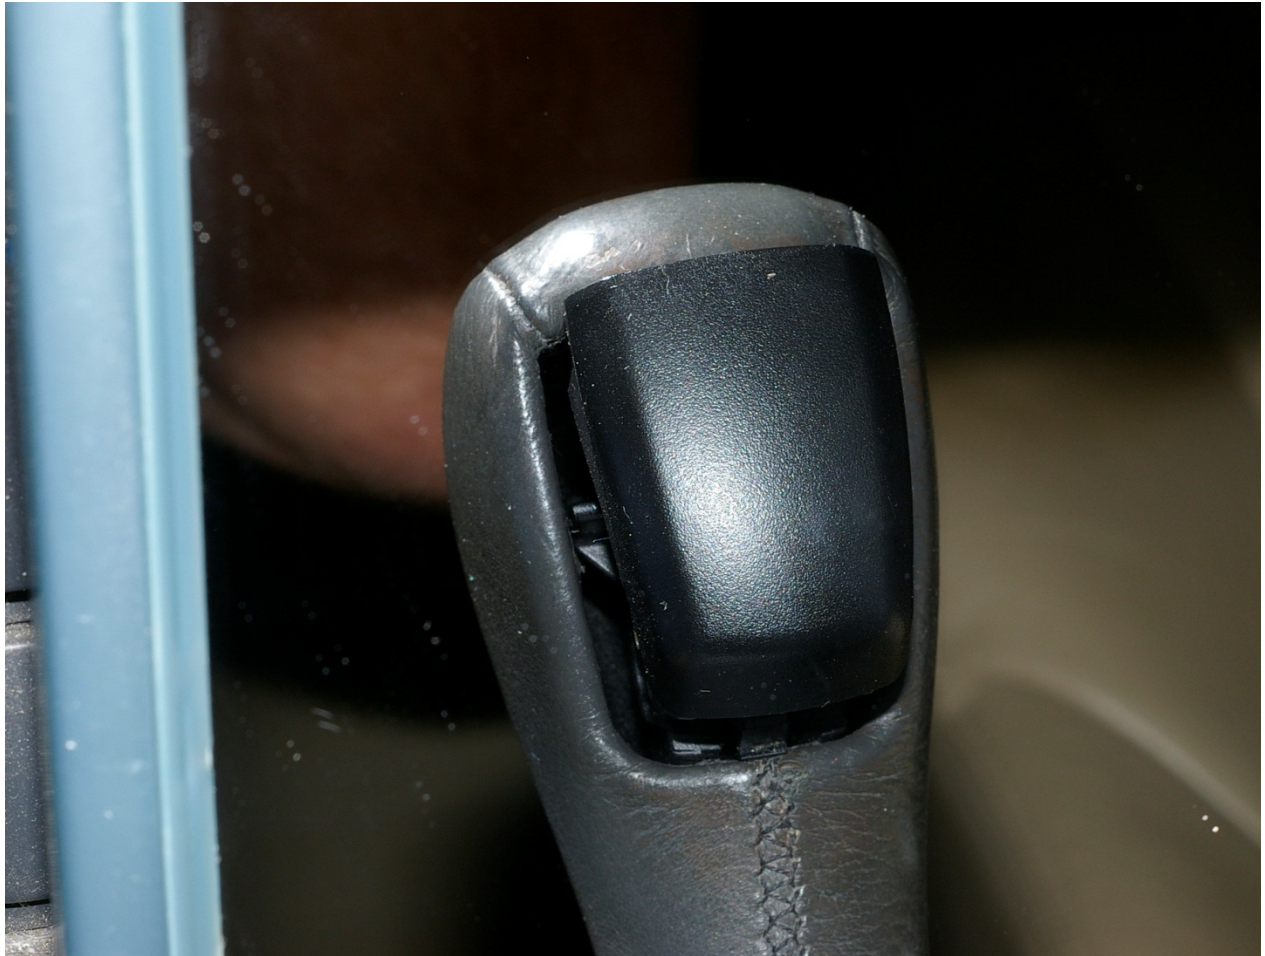
Figure 1 Remove and Install button assembly- To remove interlock button assembly carefully pry out from the top using a screwdriver and then slide out. It's just a press fit into the knob cavity. To assemble, slide back in making sure the shoulder tabs on both sides slide under shelf guides in cavity (photo below). Need to angle assembly slightly to install. Metal rod must engage in hole of interlock slide in back of cavity.

Note small vanity mirror used to take this picture and used for this repair. It helps a lot.

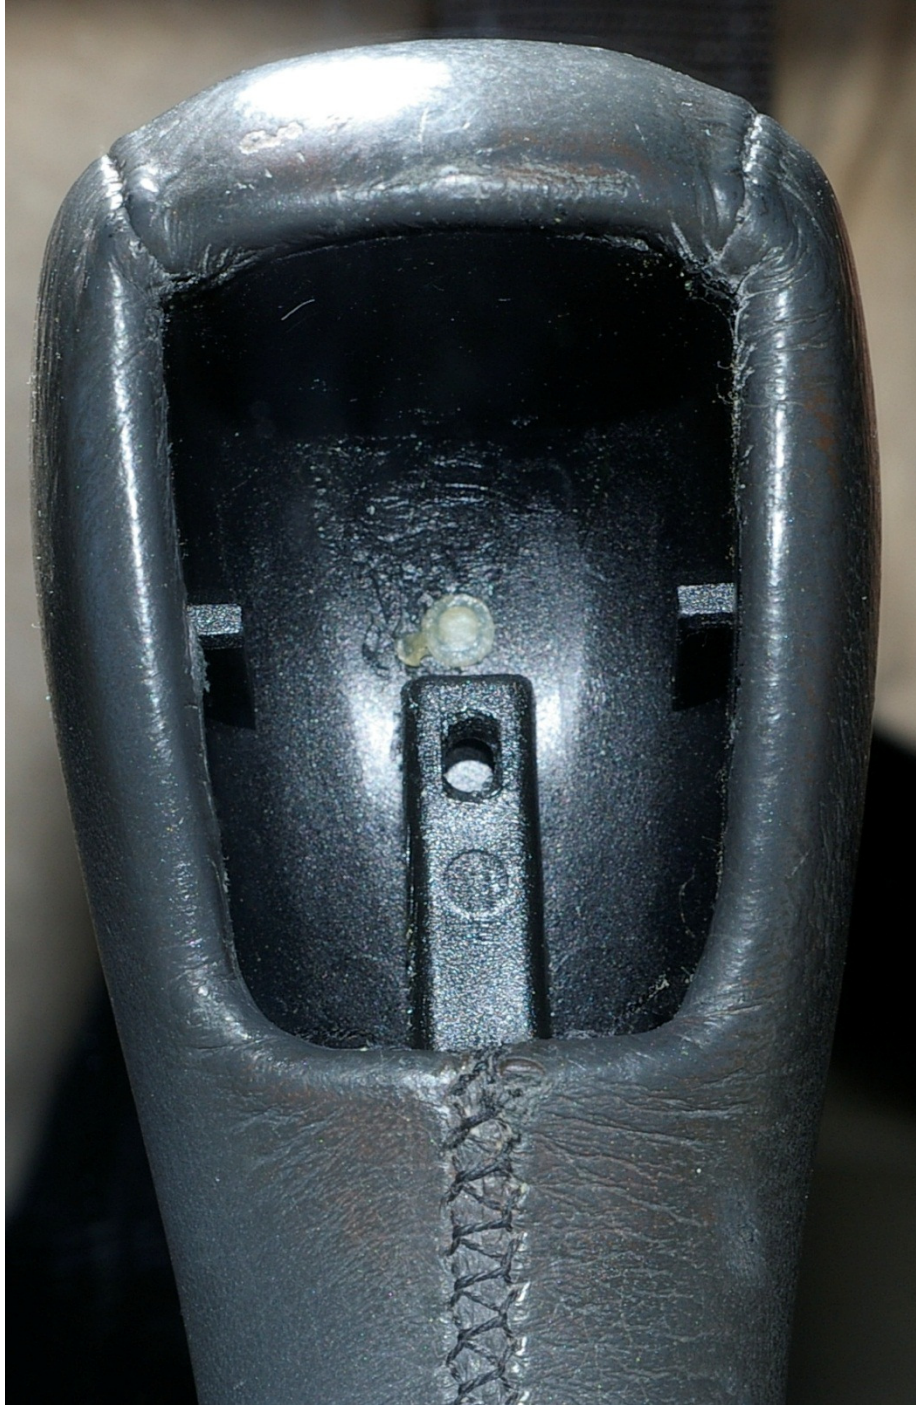
Figure 2 With interlock button assembly removed you can see the guides where the interlock assembly side tabs much go under when installing, also note the hole in the interlock linkage, which is where the rod of the interlock assembly must engage. A little tricky to align rod with hole but it didn't take too long to get in engaged correctly. With the button released the hole is at its lowest position and the shifter is locked. Linkage is pulled upward when the button is pressed.

Note: if you need to move the shifter to or from park with the interlock assembly removed or due to damage of the assembly you can remove the interlock assembly and pull up on the linkage to move the shifter. It's doesn't take much force to move the linkage but you might need to insert something in the hole (I used an old bike spoke) or small needle nose pliers to grab the sides and pull it up. The linkage does tend to fall back down into the lock position. Vanity mirror really helps.

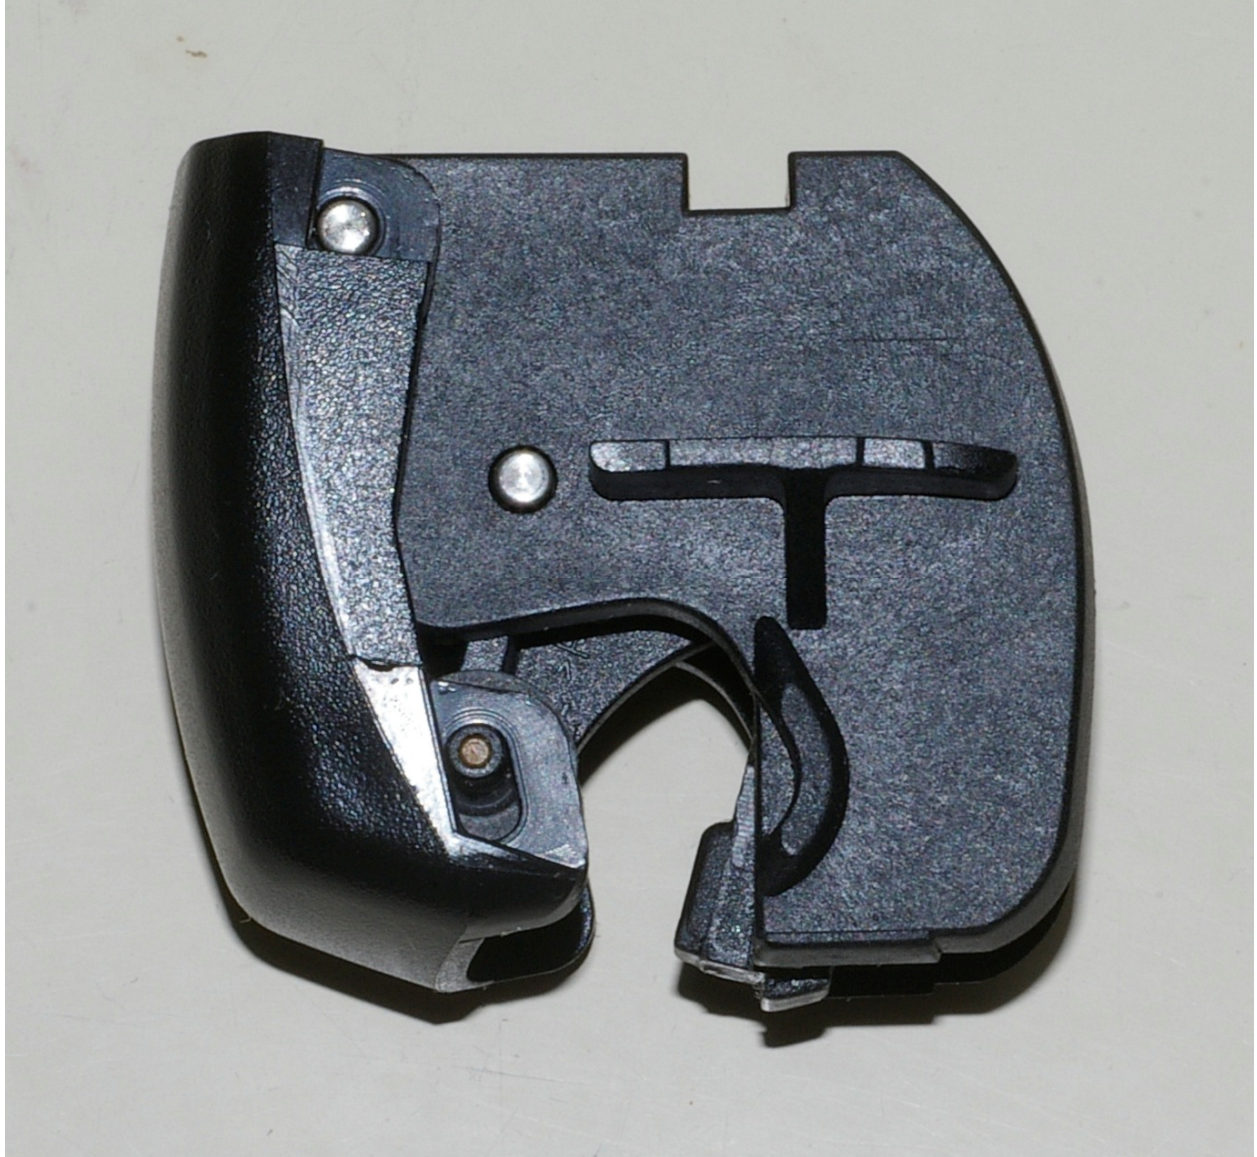
Figure 3 Here's what the interlock button assembly looks like removed and with the new button installed. There are two pins, the top pin has a return spring installed when the pin is pressed in and the lower pin has two plastic bushings that slide in the bottom slot of the button.

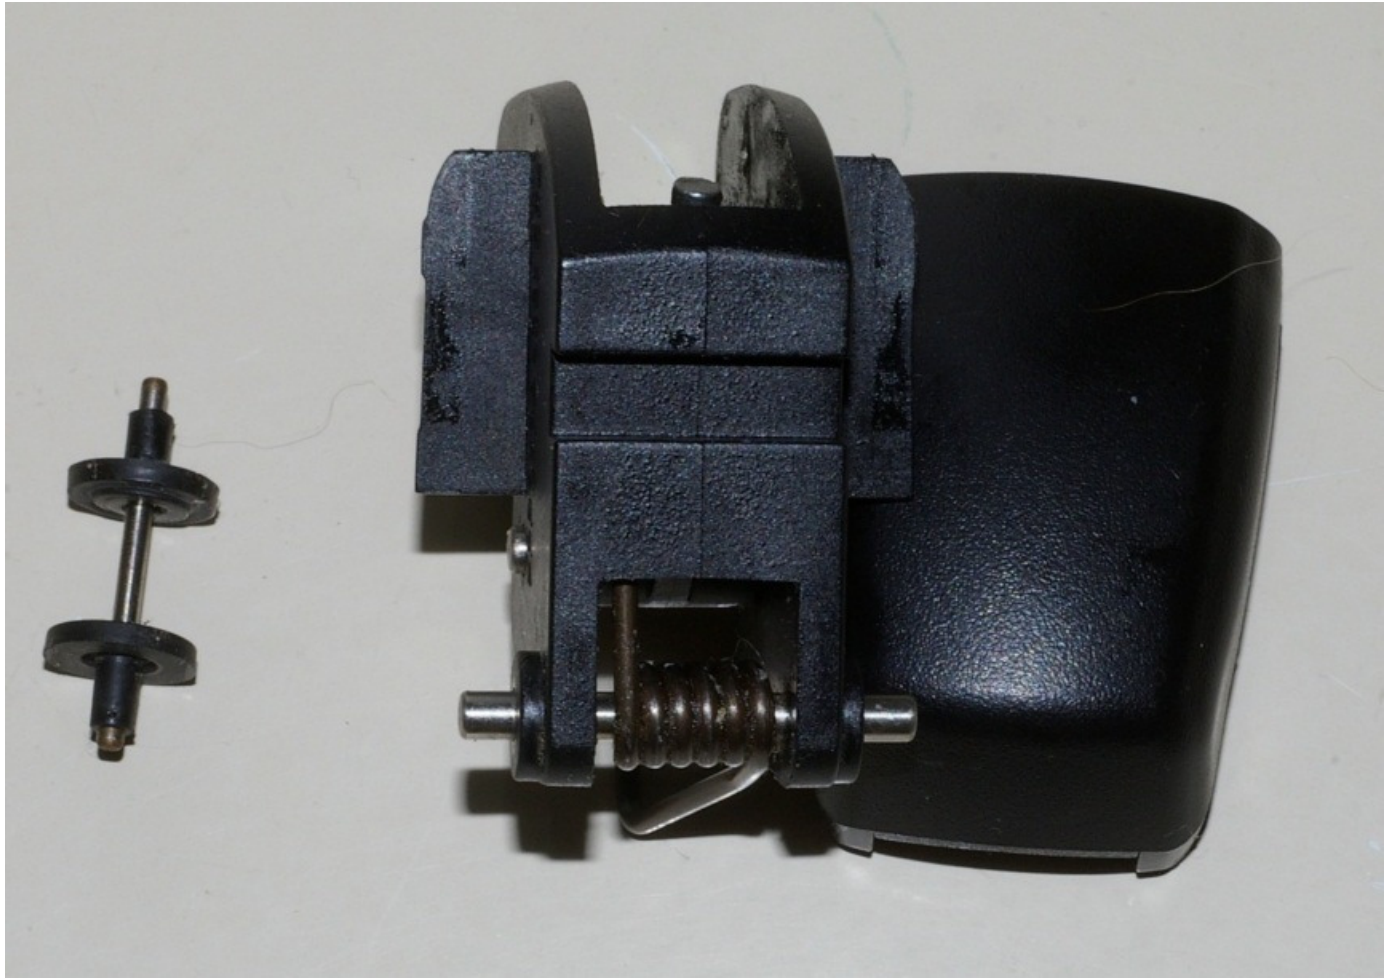
Figure 4 Looking down at the top of the assembly with interlock button removed. Top pin has a spring; lower pin has two plastic bushings. The button in my car broke in half and the plastic bushing pieces just fell out so be careful to locate these pieces and I could see them even dropping into shift knob cavity. The top pin looks like it also has plastic bushing (or maybe just part of the piece) but they did not fall out in my case and I just noticed them in the photo. Something else to look for when doing the repair.

Note the end of the metal rod sticking out the back of the assembly; this is what engages in the interlock linkage. When the button is pressed in the metal rod rotates up and pulls the interlock linkage up, which disengages the gear shift lock.

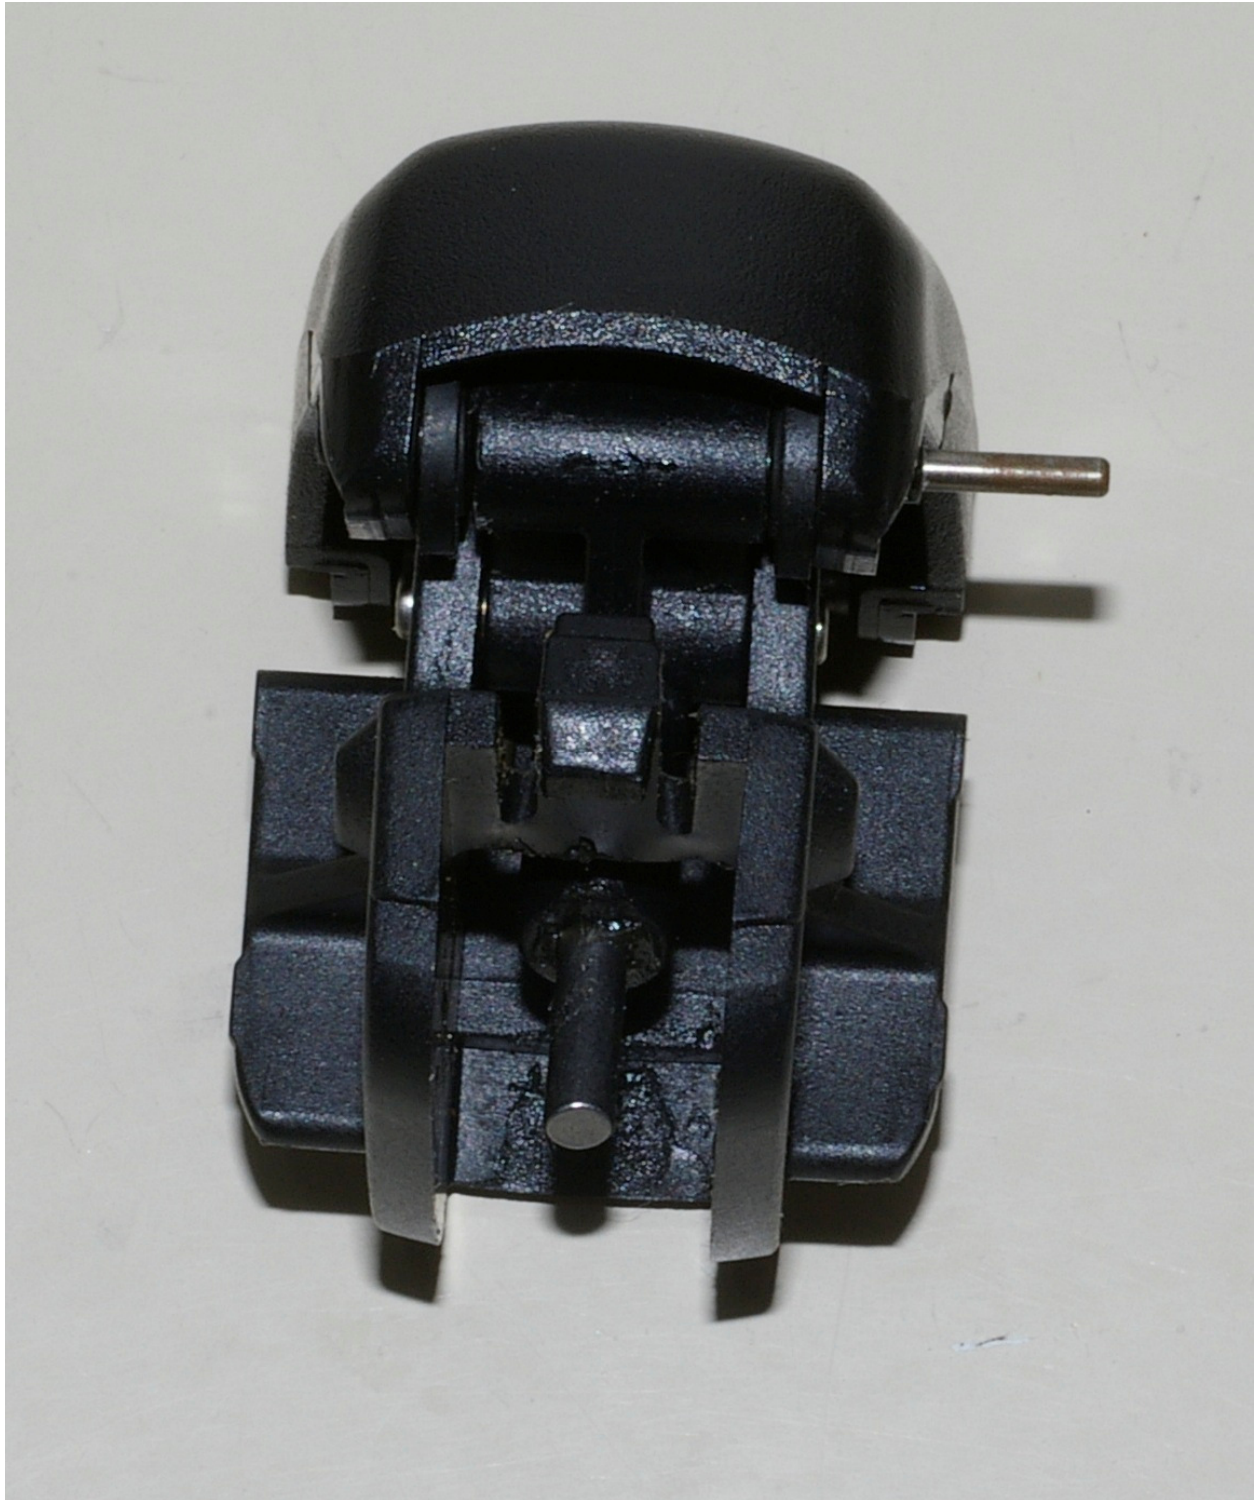
Figure 5 To install new button the top pin is pushed in from one side with spring in place. Pin is an easy press fit. A good view of the rod in the back that moves the linkage up when the button is pressed.

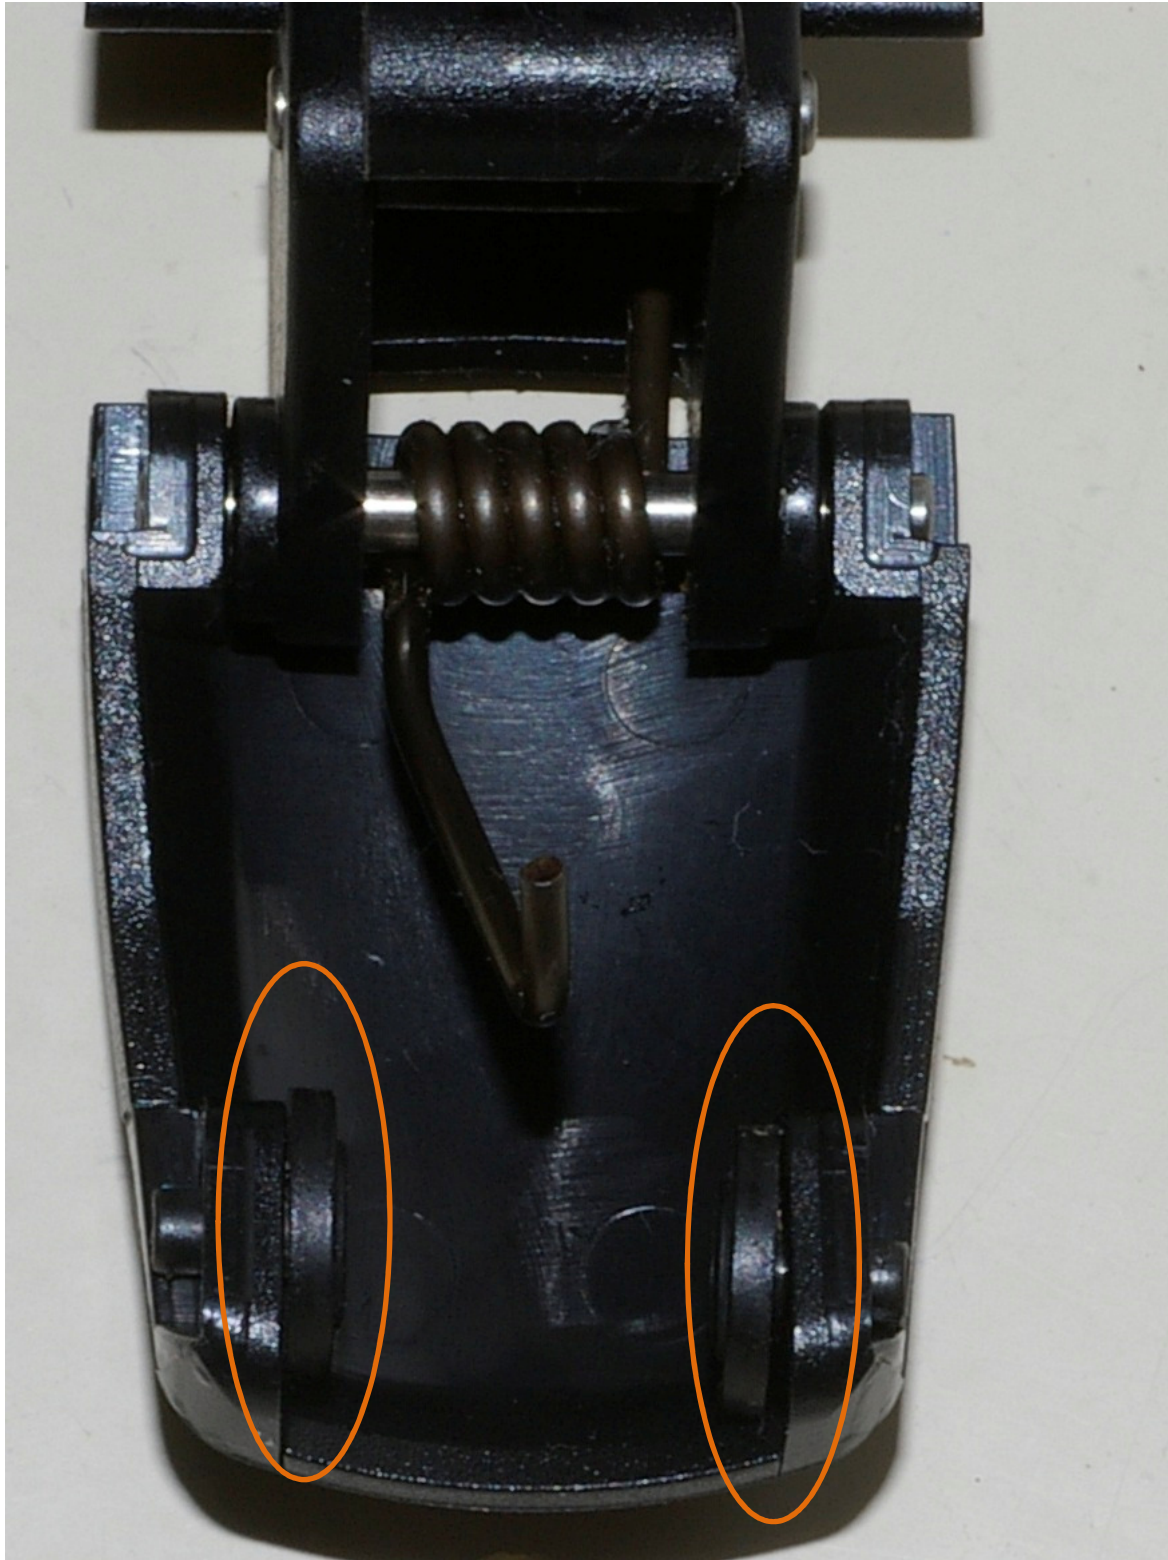
Figure 6 Before installing bottom pin, the two plastic bushings must be in place. Once the bushings are installed in the bottom slots of the button just rotate the button and align the pin hole to install the lower pin, a light press fit

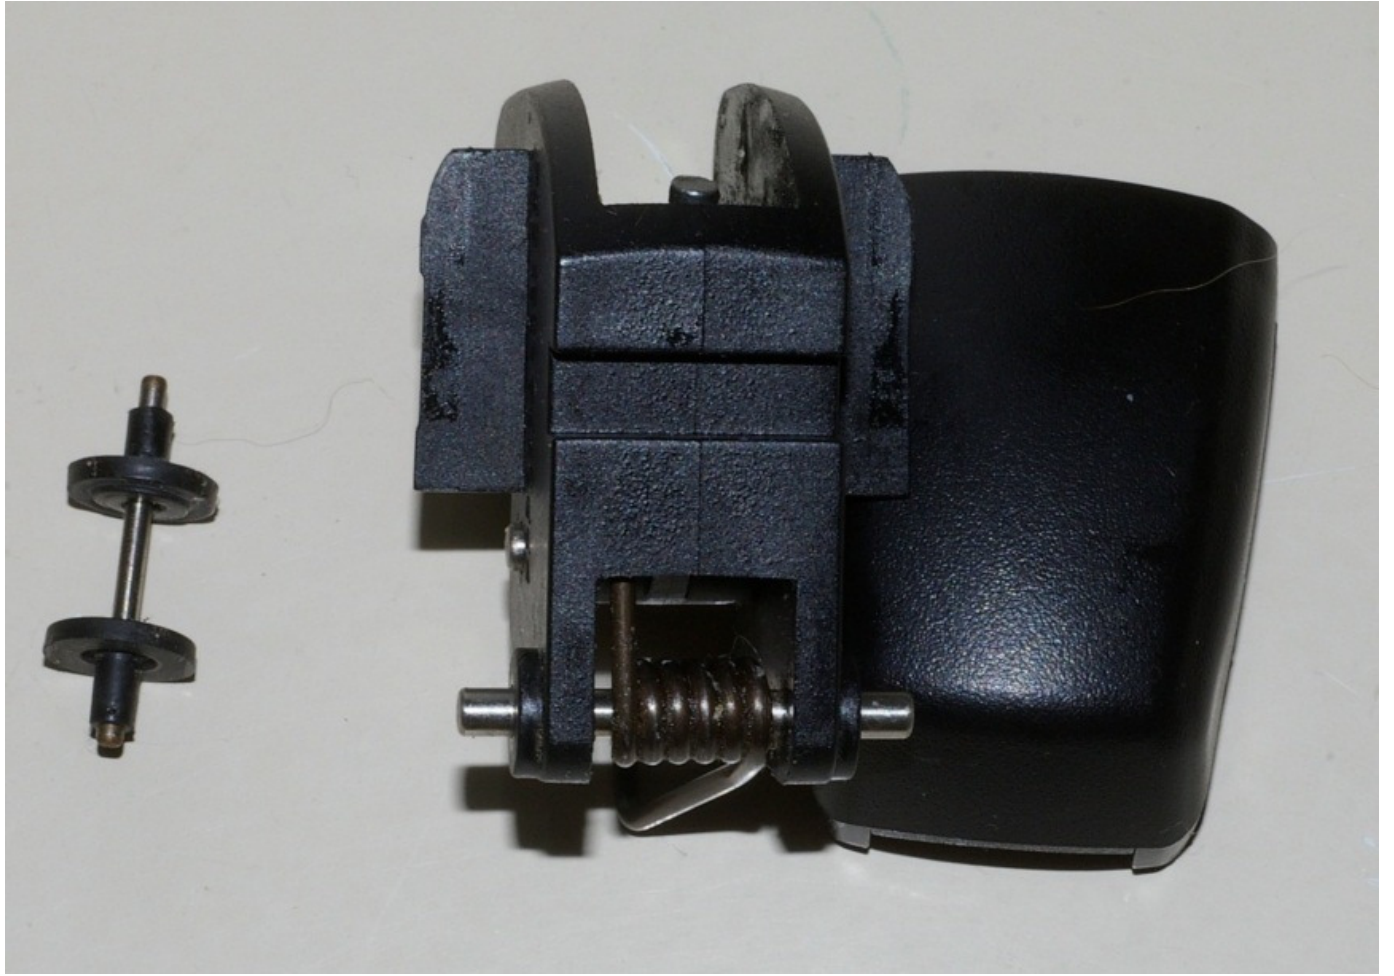
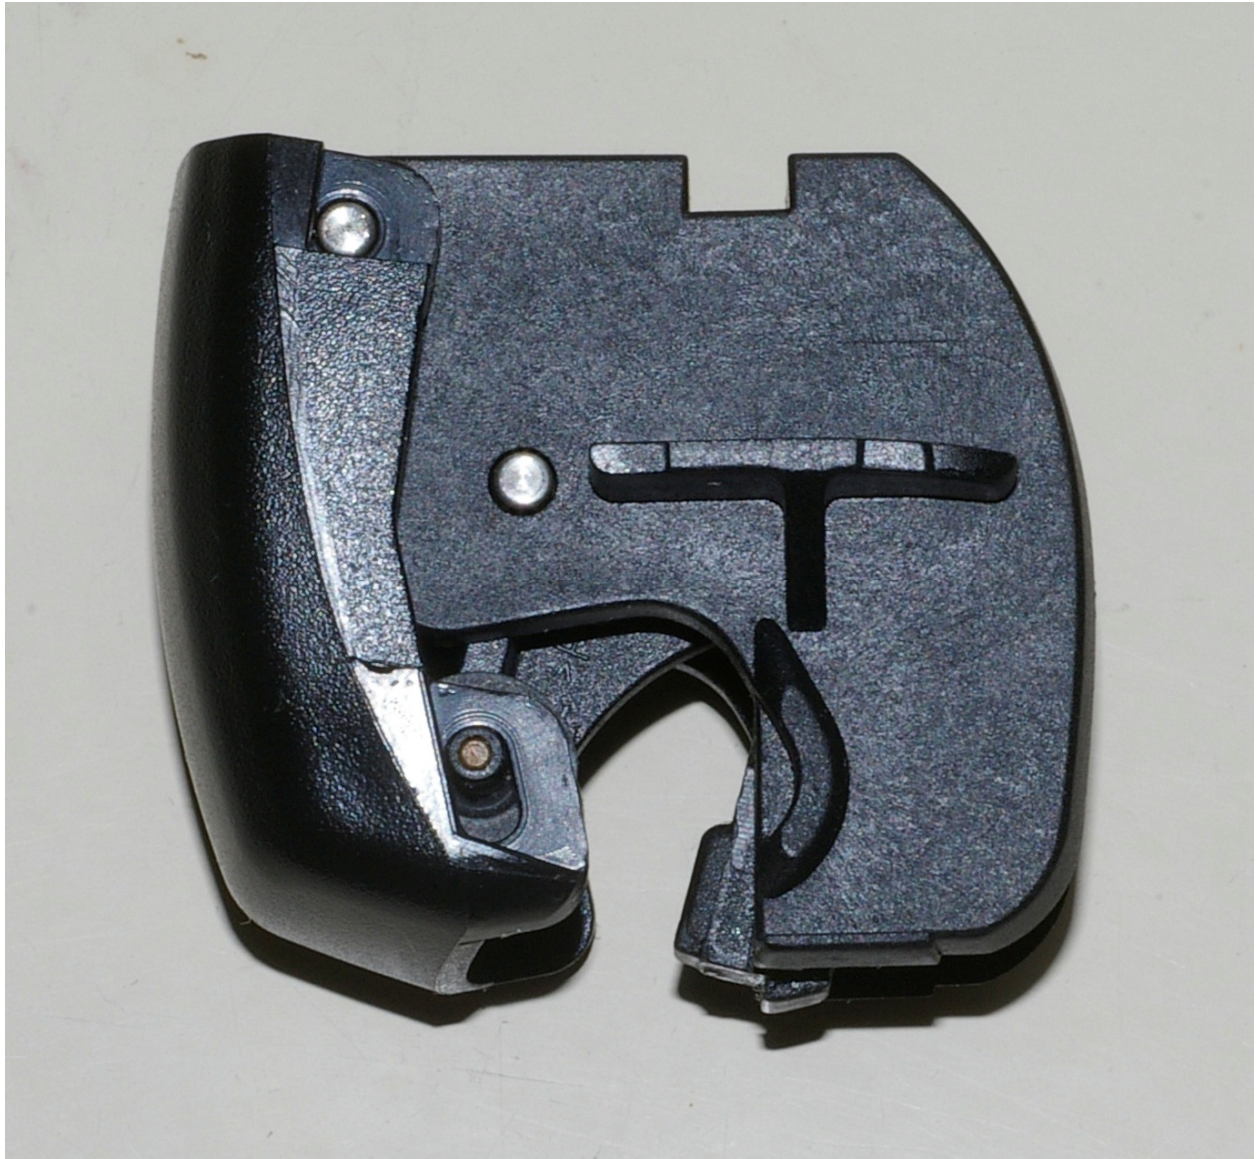
Figure 7 Both pins installed and ready to install assembly back in the shift knob cavity. Assembly is just a wedge fit in the knob cavity. The side tabs slide under the shelf tabs in the cavity and the bottom in a press fit to lock it all in place.

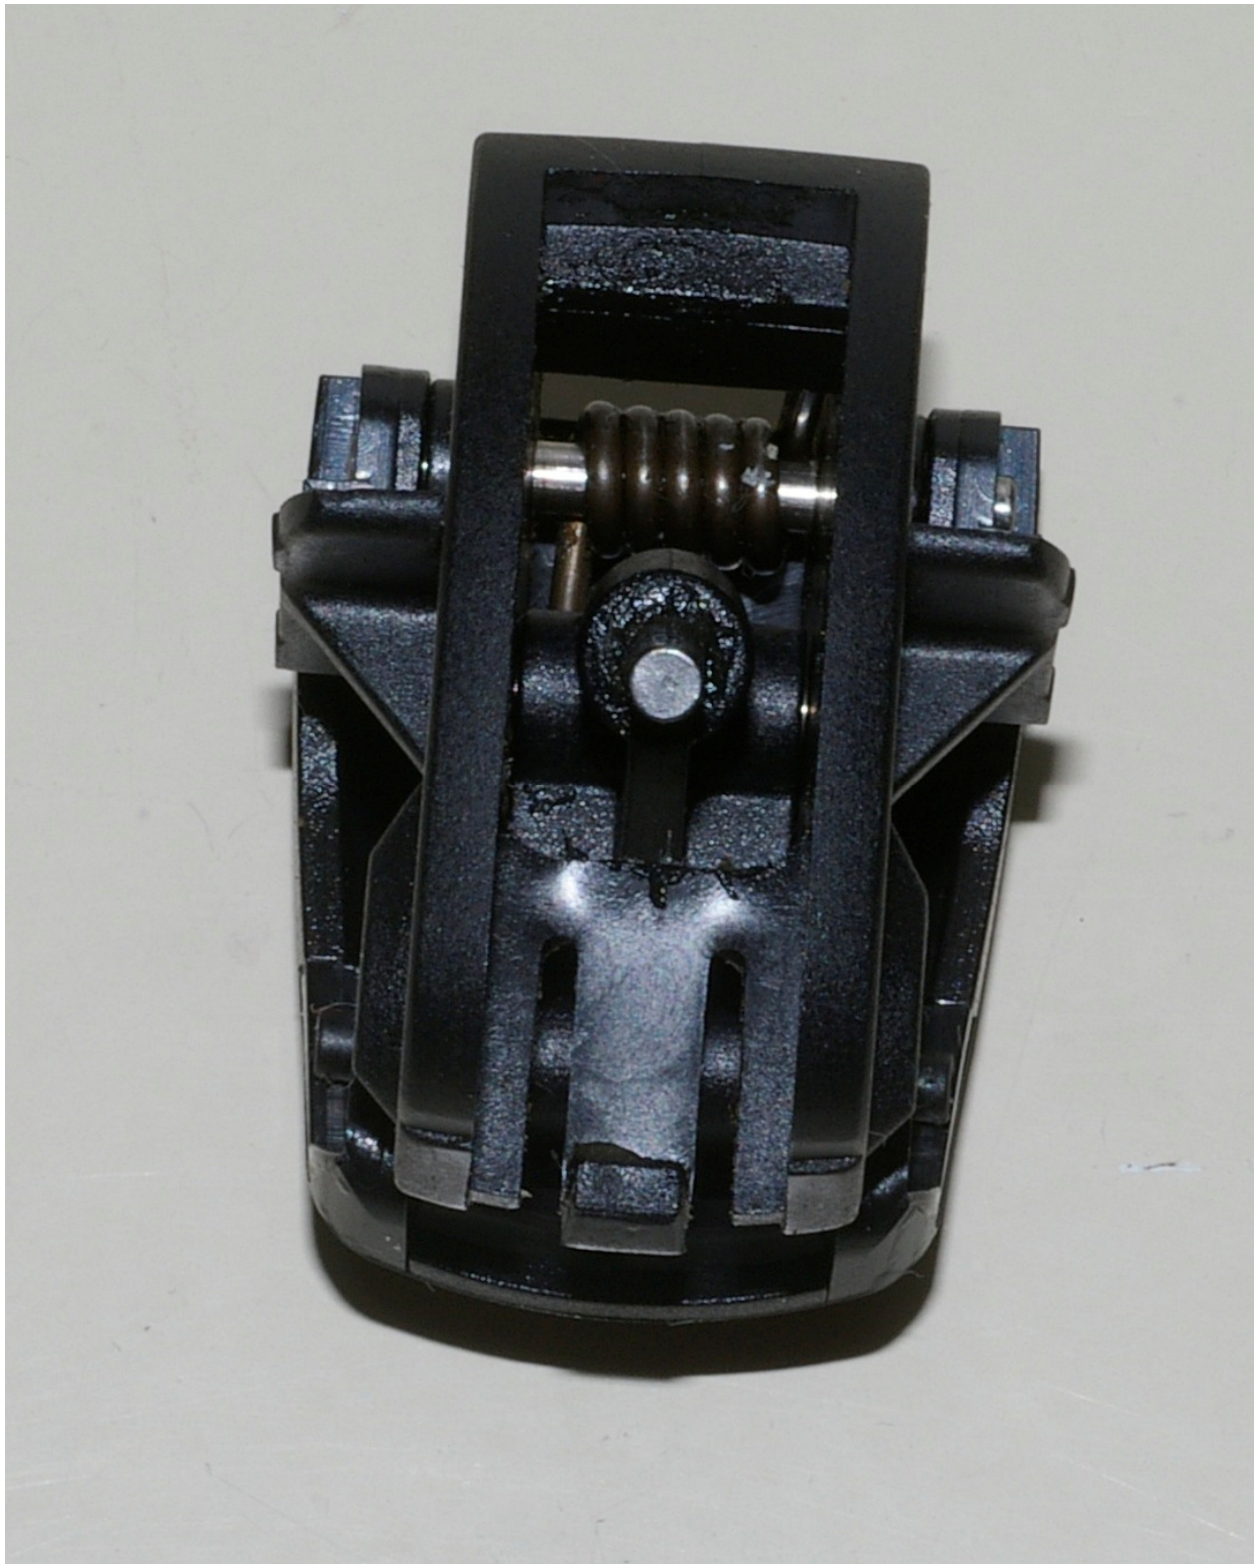
Figure 8 Back of interlock button assembly showing rod that moves the linkage. When button is pushed the rod rotates upward.
