If you find that you have a rattle in the rear of the car that you can't pin down, it is possible that your rear sway bar bushings are on the way out. In my case, I was told during my bi-annual inspection that the rear sway bar bushings were going away which was good as it did explain a rear rattle that I couldn't find despite unloading everything, including the spare, in an effort to trace it. So a quick look in VIDA revealed that Volvo, in their infinite wisdom, departed from pretty much normal practice of having separate pieces in the sway bar assembly by designing a single available assembly that encompasses the bar, mounting bushings and a 2-part bracket. Some have said that the bushings are vulcanized onto the bar but I could find no evidence of that with mine. Apparently Volvo wants \$175+ for the bar assembly plus whatever labour it takes to remove one rear coil-over and drop the rear exhaust to R&R the bar (2-3 hours according to some folks' experience) versus the more common practice of charging \$8 or so apiece for the bushings and whatever labour it takes to unbolt two bolts per bracket to replace the bushing (maybe 15 minutes total?). So there has to be a better way.

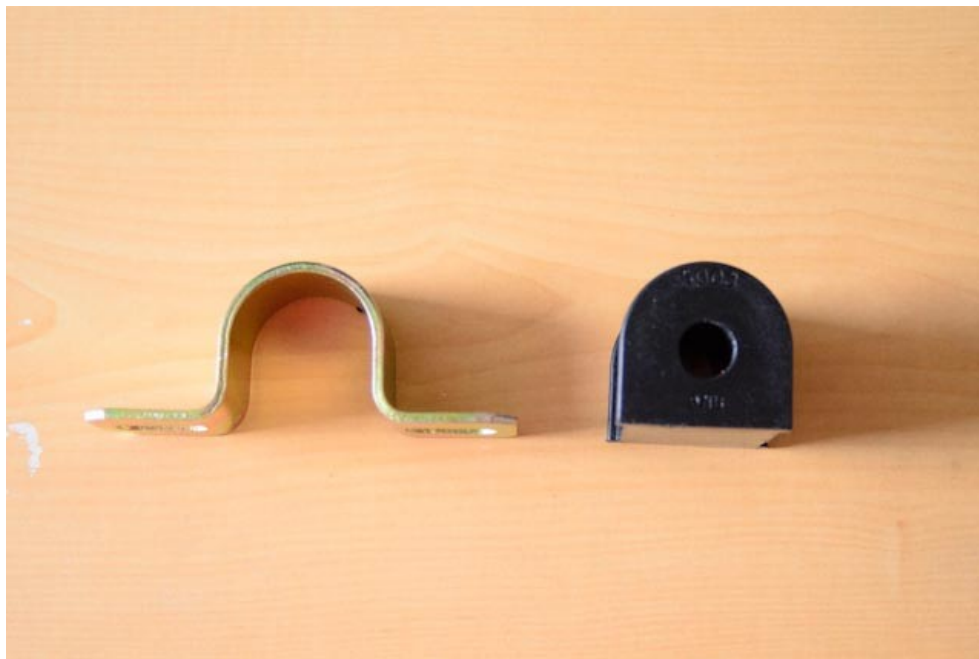
The first step was to try and find some kind of bushing. My XC has a 14mm rear bar and I believe that this is standard throughout the '01-07 model years. A search for cars with 14mm bars found a fair number, such as Acuras, Hondas, Mazdas, and Toyotas, but none of these had a bushing design that was comparable to Volvos. A BMW 540i has a bushing design that is exactly the same as what Volvo uses but the overall size of the bushing is slightly smaller than Volvos and therefore would not fit the bracket properly. To their credit, Volvo seems to use a fairly beefy bushing for a small bar. I went with a poly bushing from Energy Suspensions (PN 9.5103 for non-greaseable set., 9.5153 for greaseable both available in red or black). This bushing is a bit larger in overall size than the stock bushing but that is close enough as a slight modification to reduce its height is required. Photo below shows one bushing/bracket right out of the box.

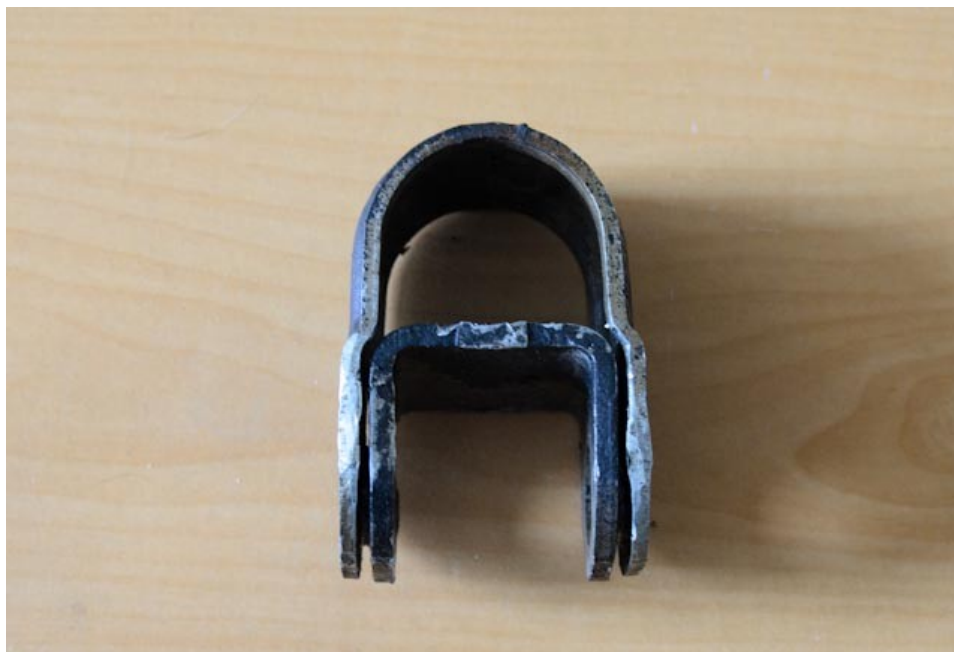
need to remove the rear wheels. In fact, the only thing you need to unbolt are the bushing brackets themselves (total of two bolts). You will note that the brackets consist of two pieces that are U-shaped with one smaller piece nested into a larger piece with the whole thing encircling the bushing and mounted with a single bolt through a boss in the rear subframe.

To begin, I unbolted both mounting brackets for the rear bar after pulling the rear of the car up on ramps. No matter how you elevate the car you need to be even side-to-side to unload the sway bar to eliminate any force that might be applied to the mounting bushings. There is no

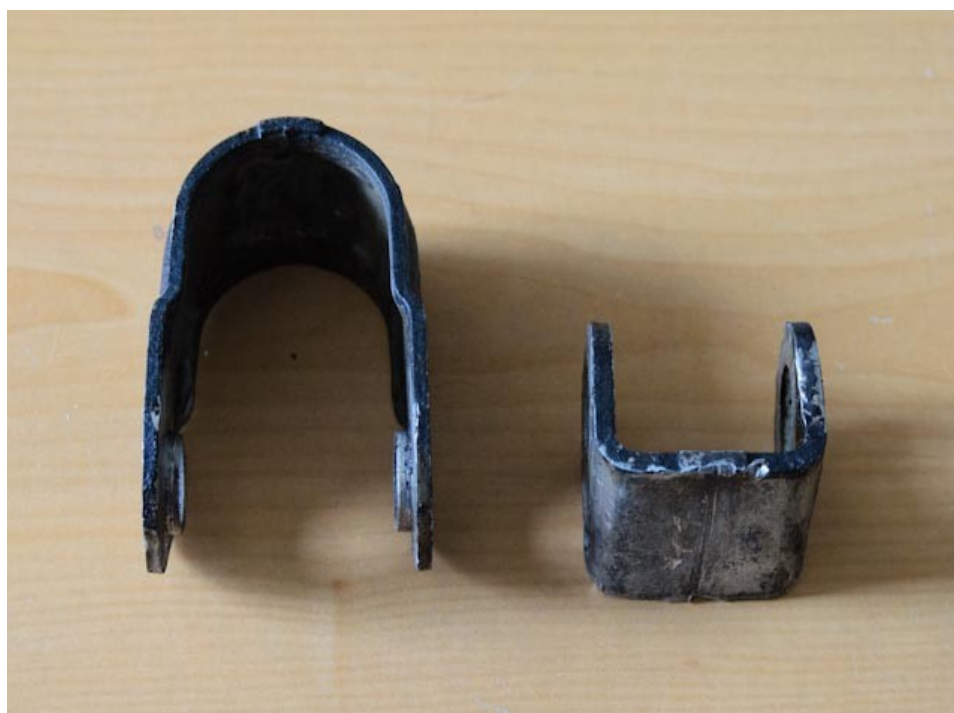
Once unbolted, twist the bracket/bushing assembly around so that the open end of the “U” is pointing down. Tap a flat-bladed screwdriver into the joint between the two pieces. By twisting the blade you can pop the bracket apart and remove it from the bar assembly.

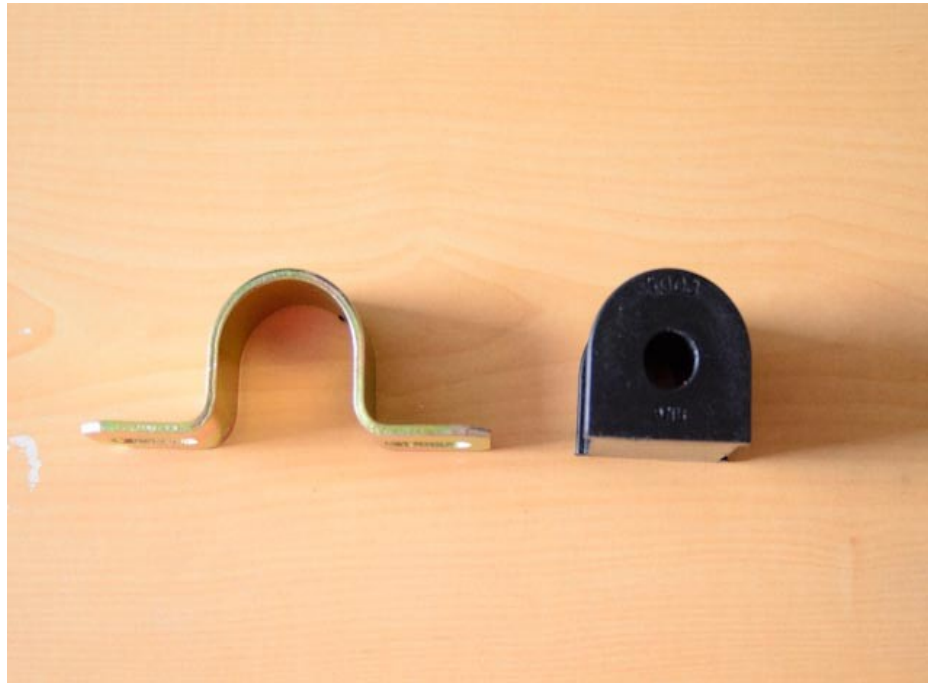
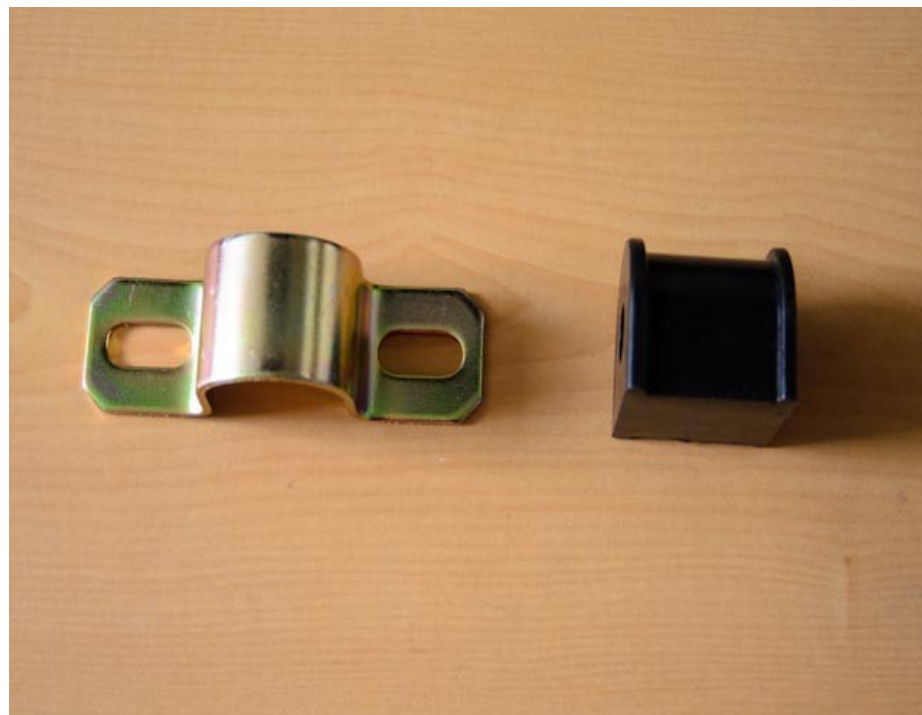
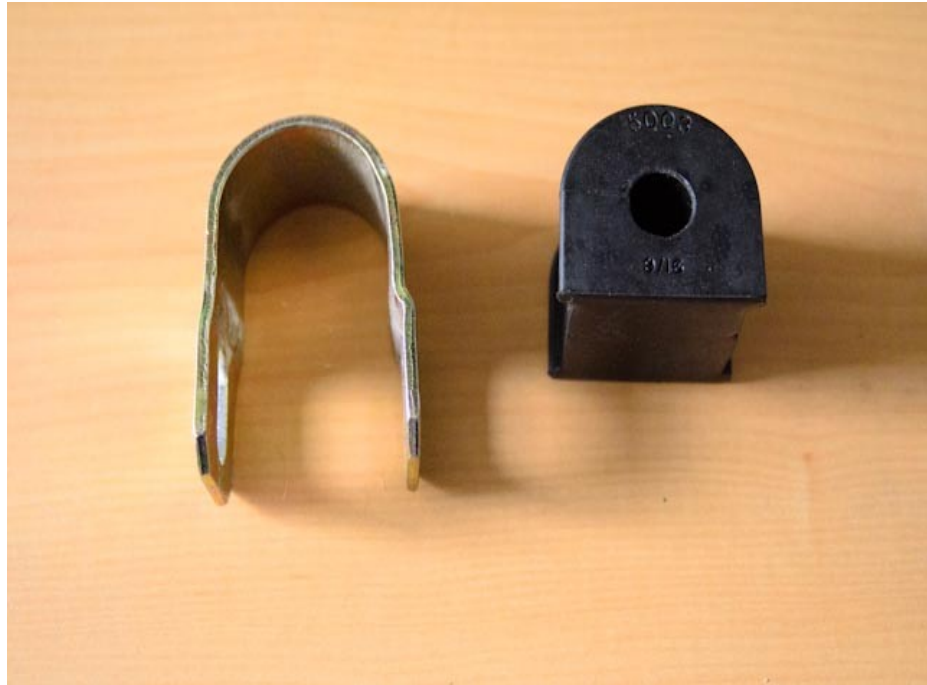
The Energy Suspensions bushing set comes with two bushing and two brackets that are shaped something like the Greek omega (Ω). By bending the bracket into a U-shape, you can use this bracket to replace the larger "outer" stock bracket.

You will also need to slightly file open the bracket's mounting holes with a rat-tail file to size them to the stock mounting bolt. It does not require much so a trial-and-error approach is best. This will give your bracket the proper configuration to contain the poly bush. However, the bush ends up being just a bit taller than the stock bushing and what the bracket (with the stock "inner" bracket nested into it) will allow, so I used my bench grinder to remove about 1/8in of the bushing height from the flat mounting side of the bush. The poly on these bushing is dense enough that a fine grain wheel actually works fairly well to make this slight "adjustment". Photo below shows the nearly finished replacement bushing sans the inner bracket and the slightly reduced in height bushing.
