Replacing turn signal stalk on 2002 V-70

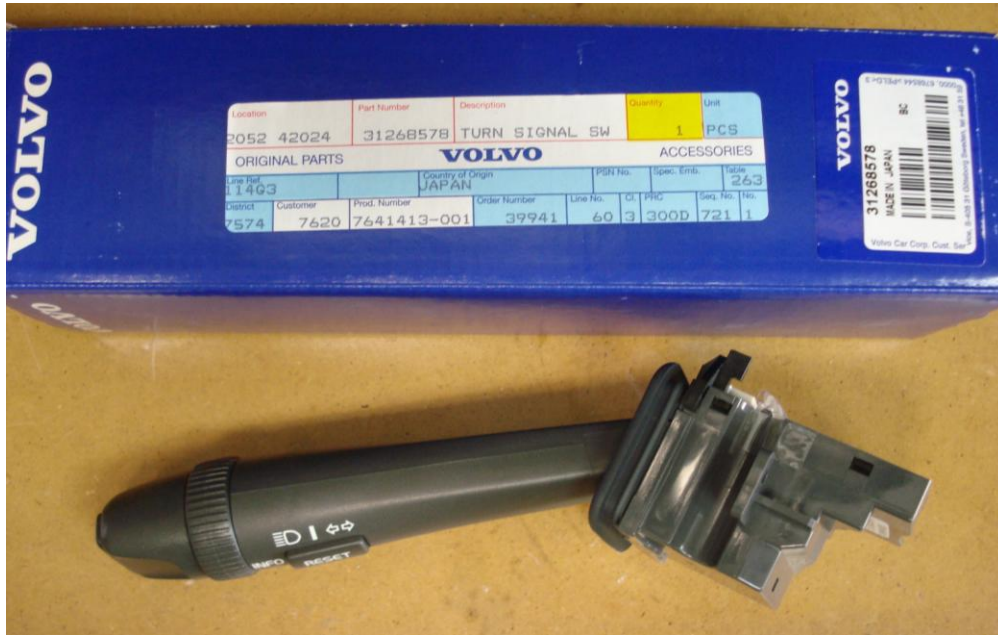
New switch shown. Note the electrical connector on the right and the gasket around the opening. Begin by removing the 3 torx screws from the bottom of the steering column cover.

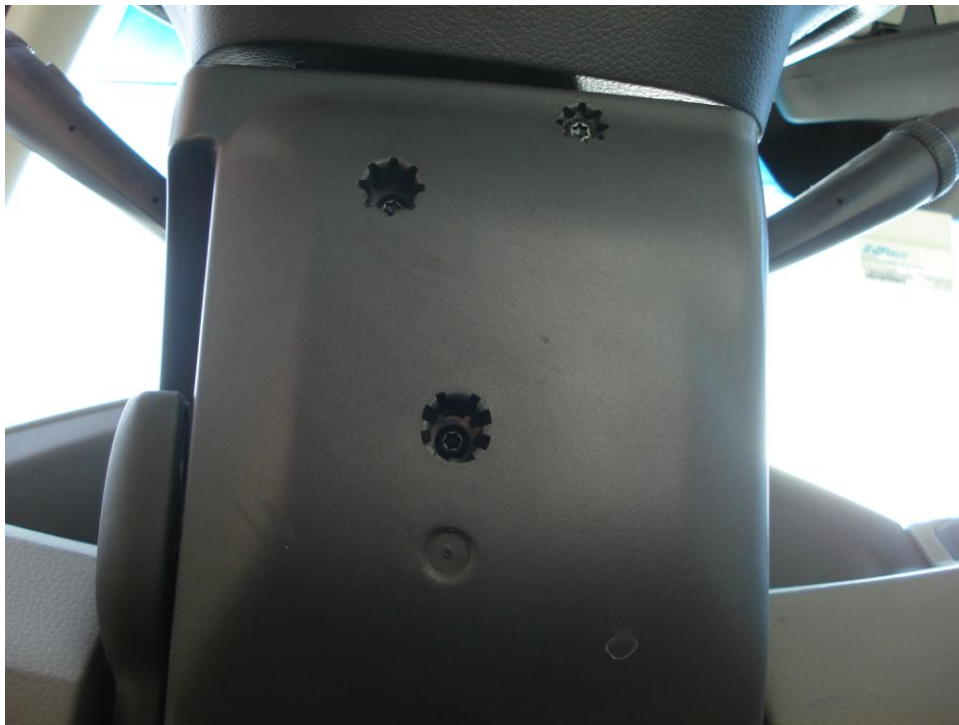
With those screws removed, pull down the bottom cover.

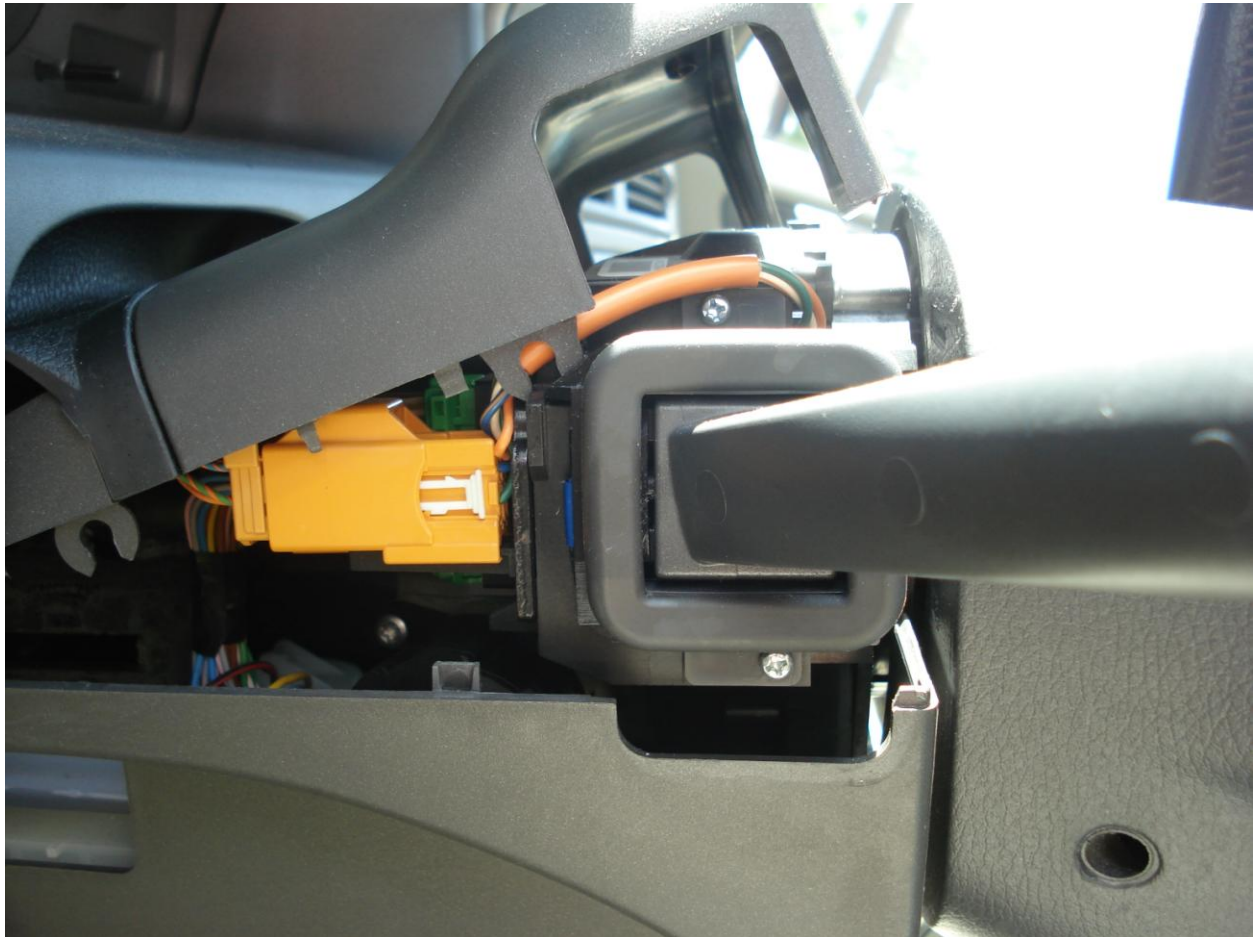
The top steering column cover is held in place with clips – seen below, pull up gently (a nylon pry tool is very useful here)

The switch is held in place by the 2 phillips head screws seen above. Undo the screws. The switch itself plugs into the 9 - pin electric socket, so it will take some moderate pressure (and a bit of working up and down) to get it free.
